CITY COUNCIL AGENDA ITEM
CITY OF SHORELINE, WASHINGTON

AGENDA TITLE:	A review of options for the Robinson Water Tower located at the intersection of NW 195th Street and 3rd Avenue NW.
DEPARTMENT:	Planning and Development Services
PRESENTED BY:	Timothy M. Stewart AICP, Director Jeffrey B. Thomas, Senior Planner

Subject: Robinson Water Tower Preservation Project

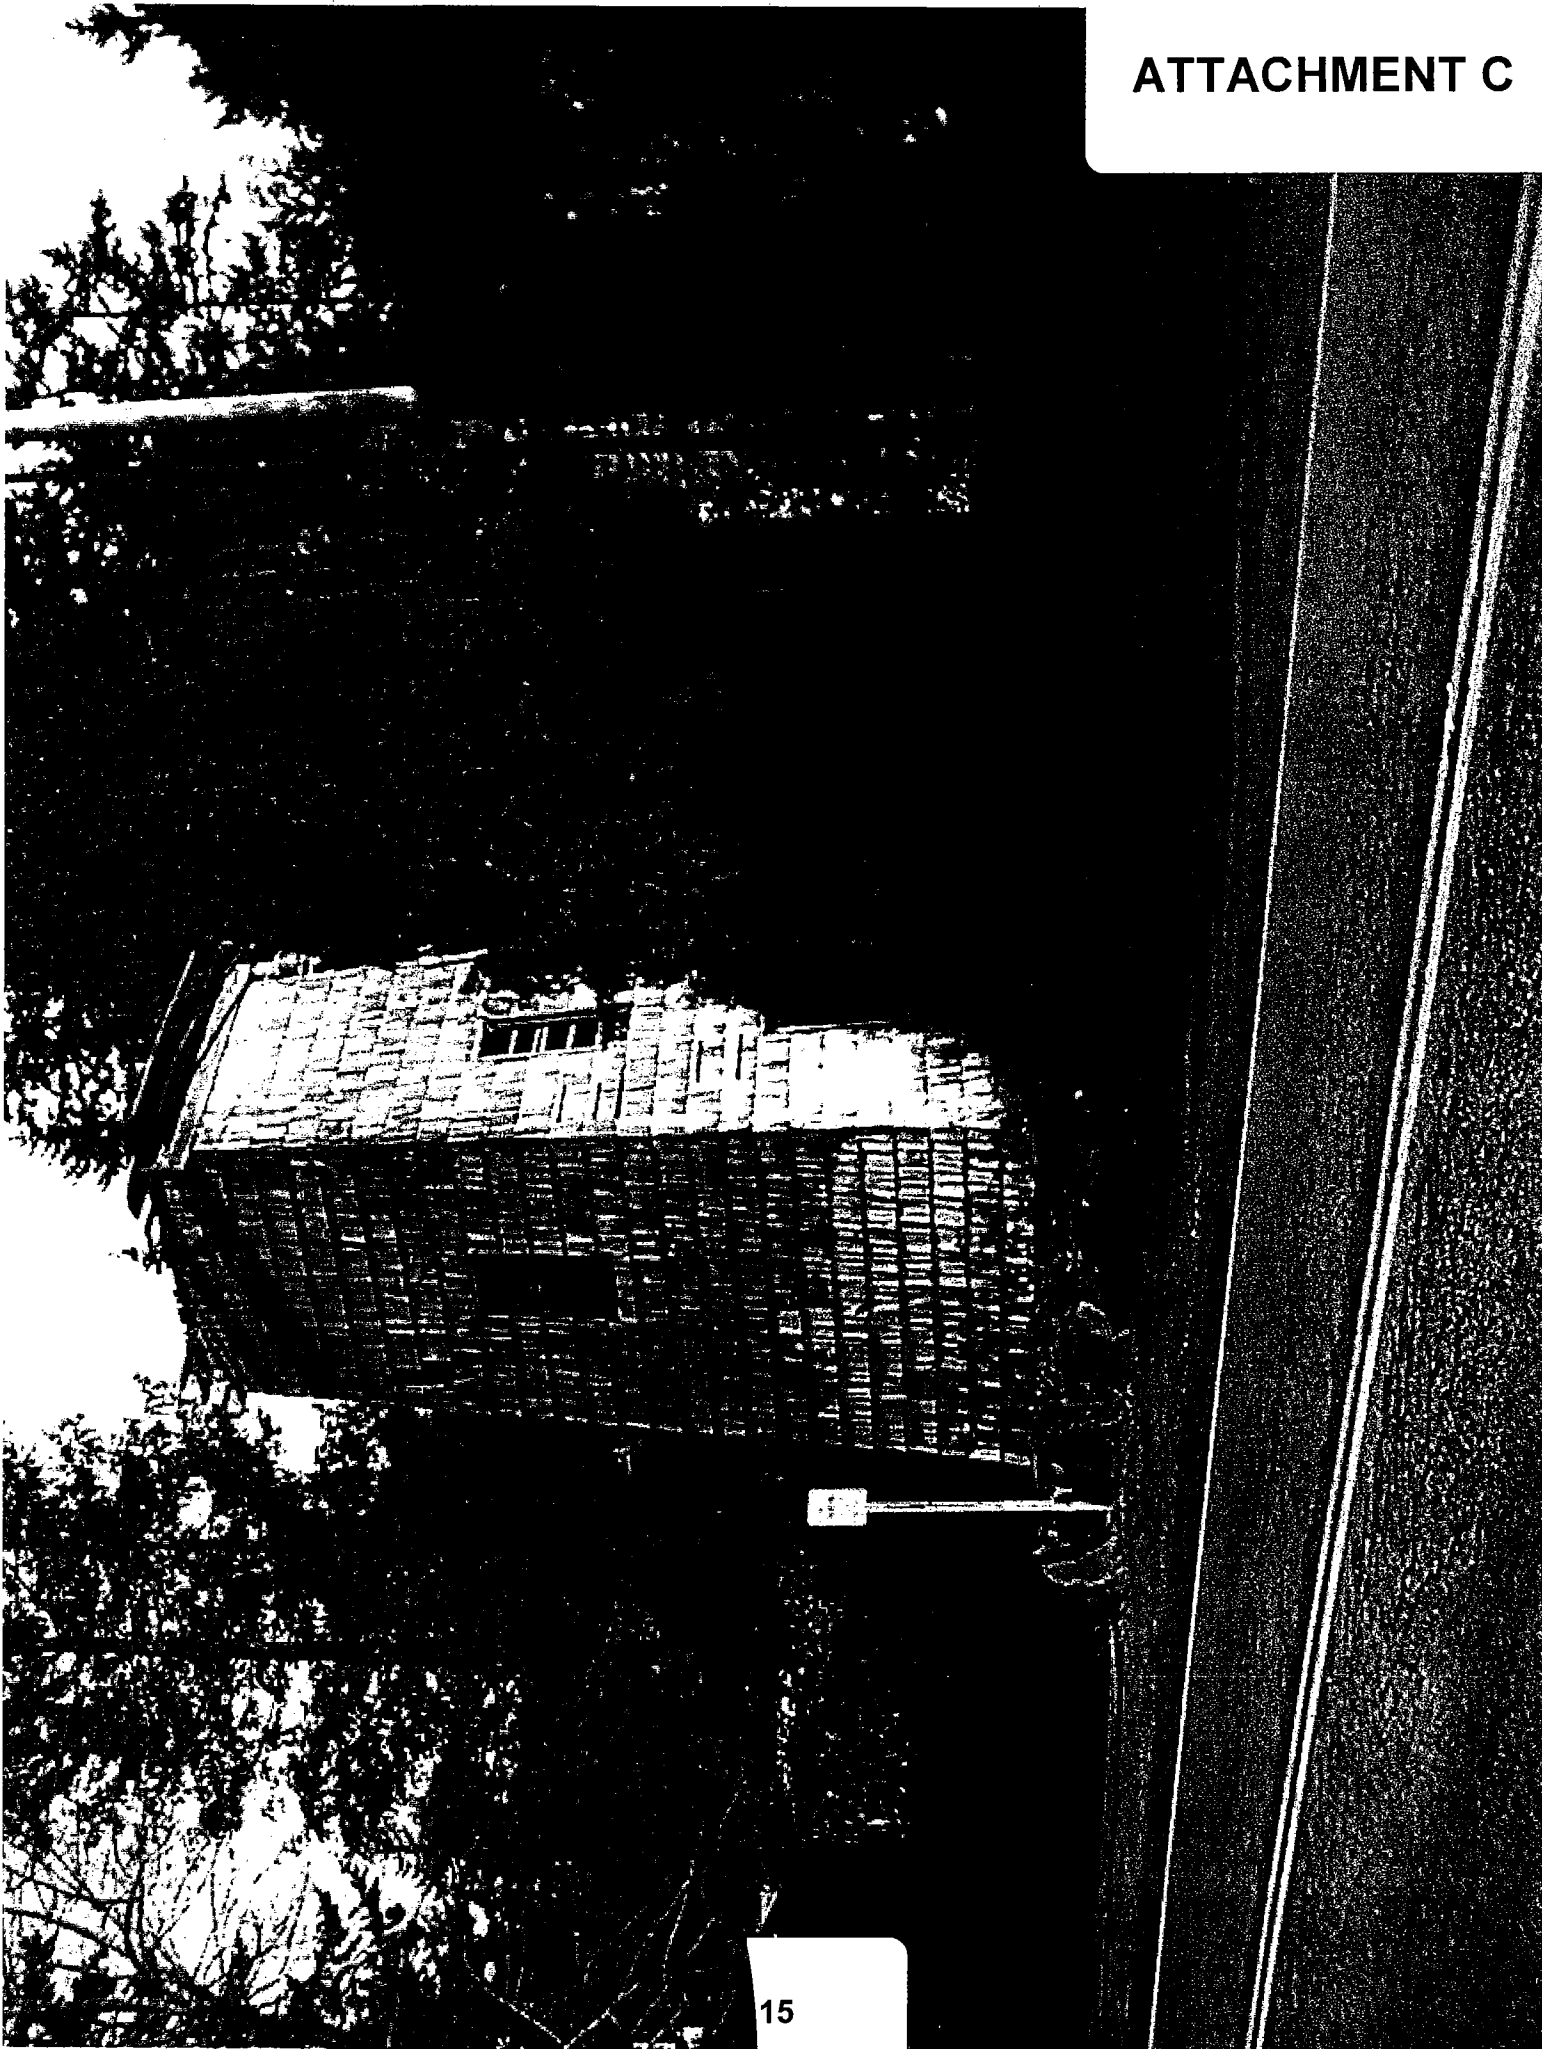
Attachment C: Current Robinson Water Tower Photograph

- **Preservation and Restoration Option** – This option is not feasible. It is believed that the existing tower, as photographed in Attachment C, has deteriorated beyond salvage. Significant labor and material cost would be required to make exact determinations for the preservation and restoration of individual pieces of the existing tower. Because of this very detailed work, a cost estimate was not prepared. However, it appears that this option may cost up to twice as much as the reconstruction option, with historical specifications and new materials.

- **No Action** – This option would leave the existing tower in its current state - exposed to the weather elements and rapidly deteriorating. Both the City of Shoreline and the private property owner would be continuing the risk of maintaining a hazardous structure.

Staff recommends that Council direct staff to move forward with the demolition option without any cost allocation plan, as the private property owner has already incurred significant expense in removing the Seattle City Light power strike. The demolition of the existing tower would relieve both the City of Shoreline and the private property owner from the risk of maintaining a hazardous structure.

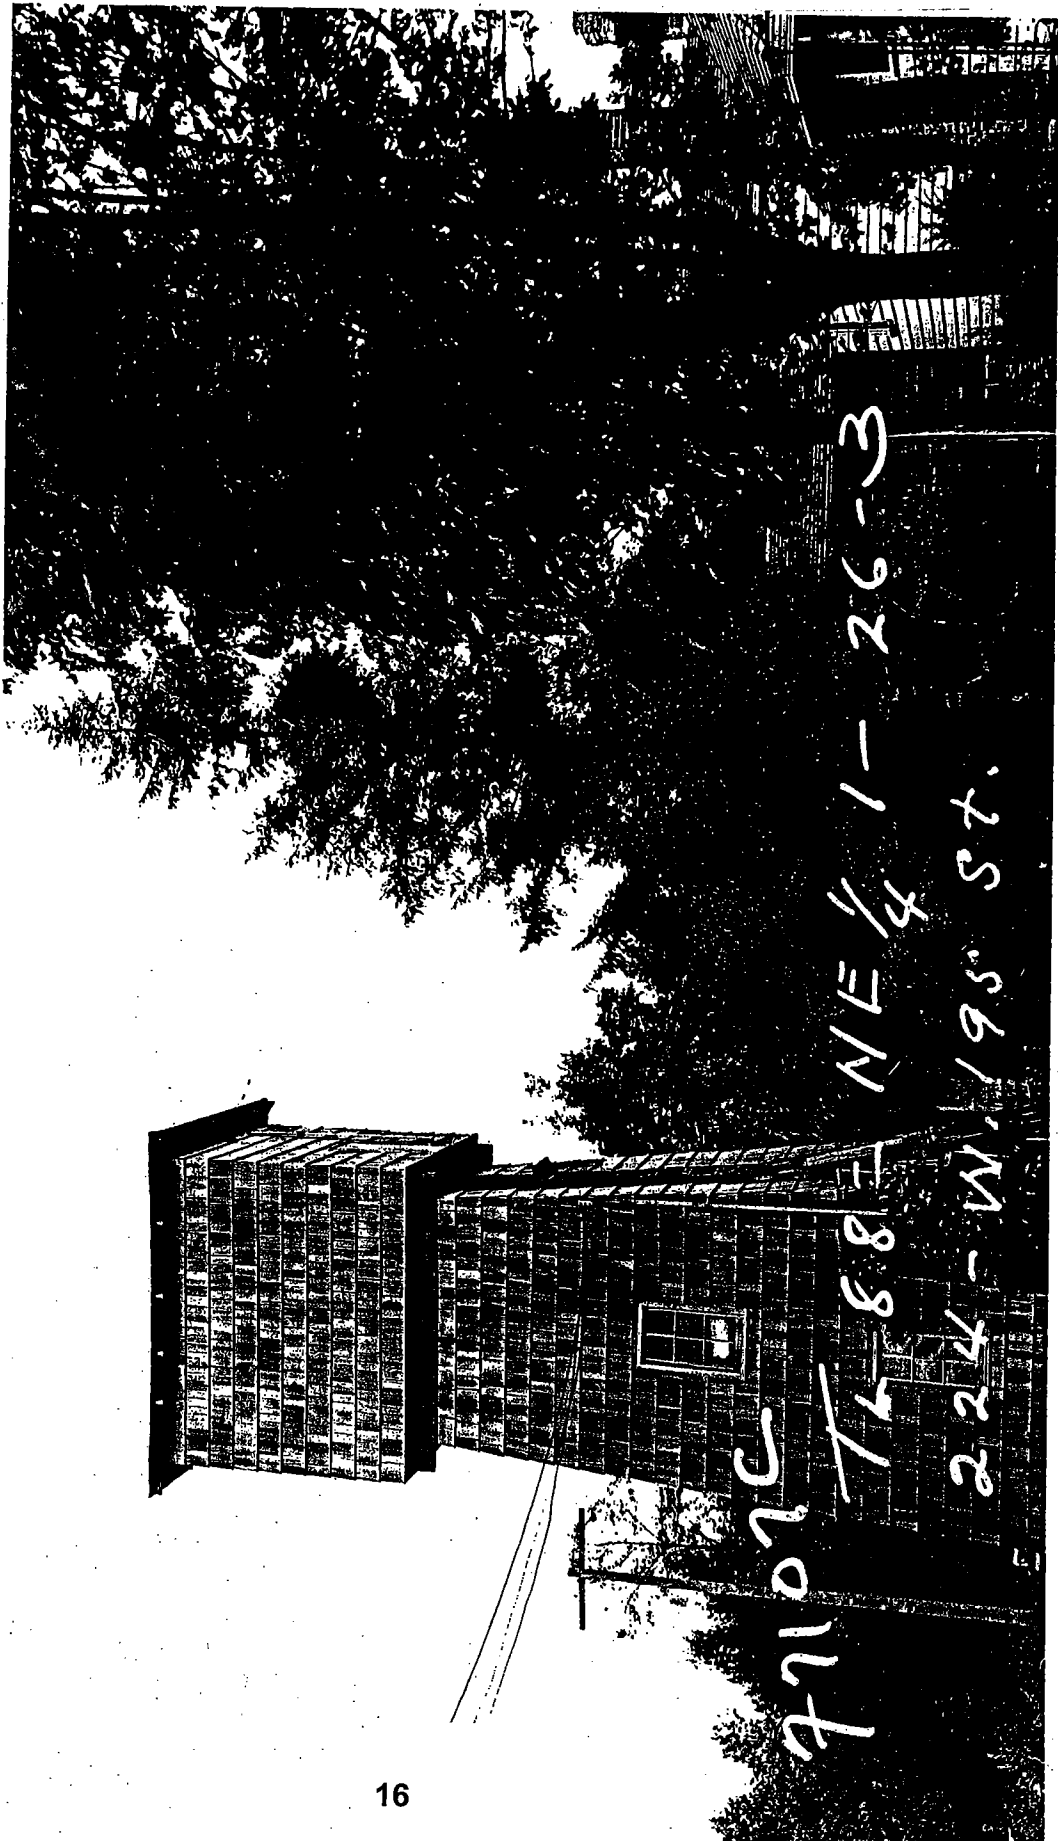
ATTACHMENT D

- **Reconstruction Option** – This option is feasible and includes demolition of the existing tower and using new materials to reconstruct the tower either at the current site or at an unidentified location, as it generally appears in a 1937 photograph, included as Attachment D. Reconstructing the tower at the current site presents both safe parking and access issues for the general public. Reconstructing the tower at another location removes it from the historical neighborhood context. The cost estimate for this option, as detailed in the final report, is approximately \$117,000, without any additional cost of land.
