DRAFT Arborist Report

To: Osborn Consulting, c/o Forrest Jammer
Site: 15600 Dayton Ave N, Shoreline, WA, 98133
Re: WSDOT Tree Impacts
Date: January 14, 2020
Project Arborist: Josh Petter
ISA Certified Arborist #PN- 8406A
ISA Qualified Tree Risk Assessor
Katie Hogan
ISA Certified Arborist #PN- 8078A
ISA Qualified Tree Risk Assessor
Referenced Documents: Grading and Drainage Plan C2.01 – C2.03 (Ankrom Moisan Architects, INC, dated 07.11.19)
Attached: Table of Trees
Tree Site Map

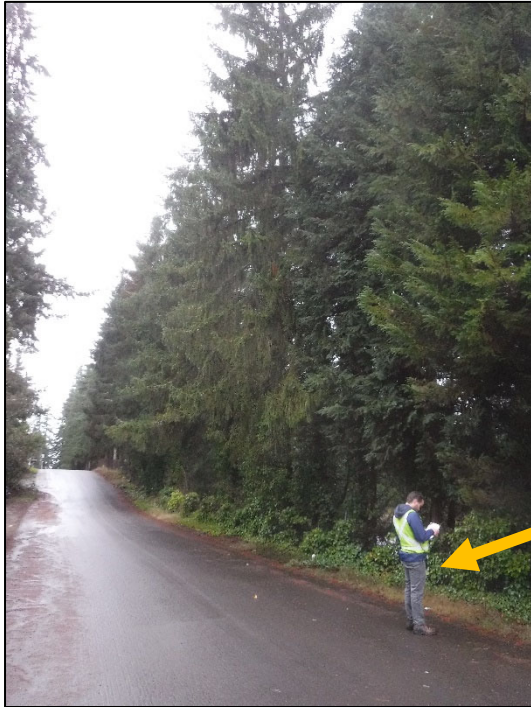
Photograph 1: Looking west along N 155th Street. A sidewalk is proposed along this road.

A 6-foot sidewalk is proposed along N 155th street that will require removal of a number of trees and impact others (Photograph 1). We assessed 76 total trees along N 155th St; 43 of which will likely require removal. In some areas, the proposed sidewalk extends to the north to the existing edge of slope. If slope stabilization is required, methods should be considered that minimize over-excavation and support tree retention. Tree Solutions can provide a detailed specification for this area once plans are

There is a high concentration of invasive ivy in this area. We recommend removing the ivy to protect the trees that will remain. At a minimum, the ivy should be cut at the base and pulled back to form a 3-foot circle; this helps keep the ivy from growing up the trunk and strangling all of the existing vegetation.

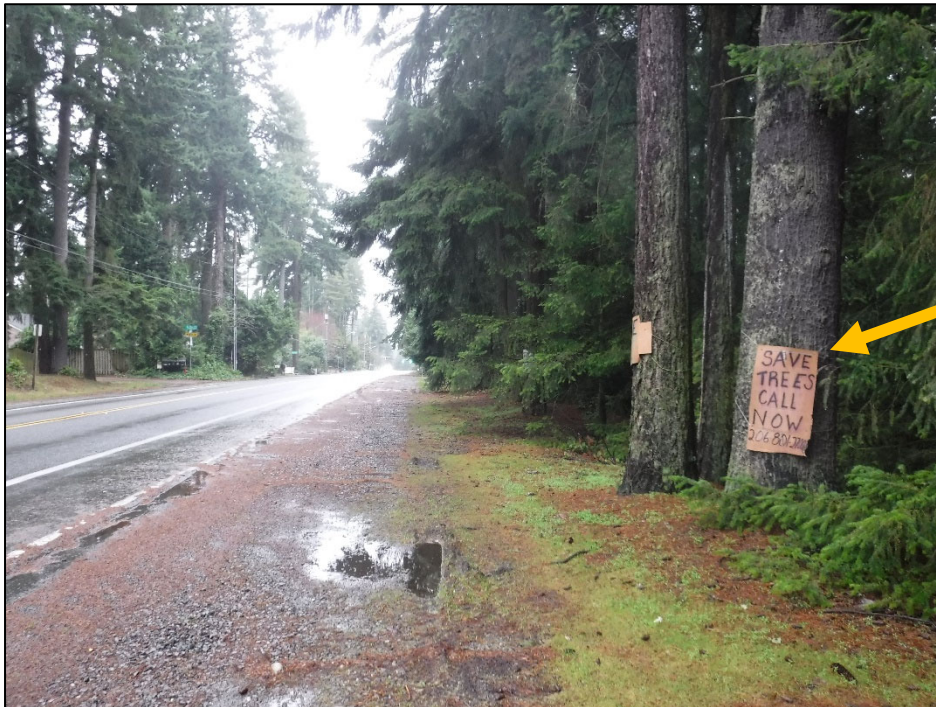
Photograph 2: Looking north along Dayton Ave N. A number of right-of-way requirements are proposed.

Currently, there is a 12-foot parallel parking, 8-foot sidewalk, 18-inch curb, and 5-foot amenity strip proposed within the right-of-way fronting the client's property along Dayton Avenue N (Photograph 2). There are a number of large-statured native trees within this area that will have to be removed to accommodate this improvement. Of particular importance is the concentration of western white pine (*Pinus monticola*) in this area. This tree species is susceptible to white pine blister rust (*Cronartium ribicola*), an invasive pathogen; however, we did not observe this pathogen on these trees. Since this tree species is becoming less and less common across the Pacific Northwest it should be retained wherever possible.

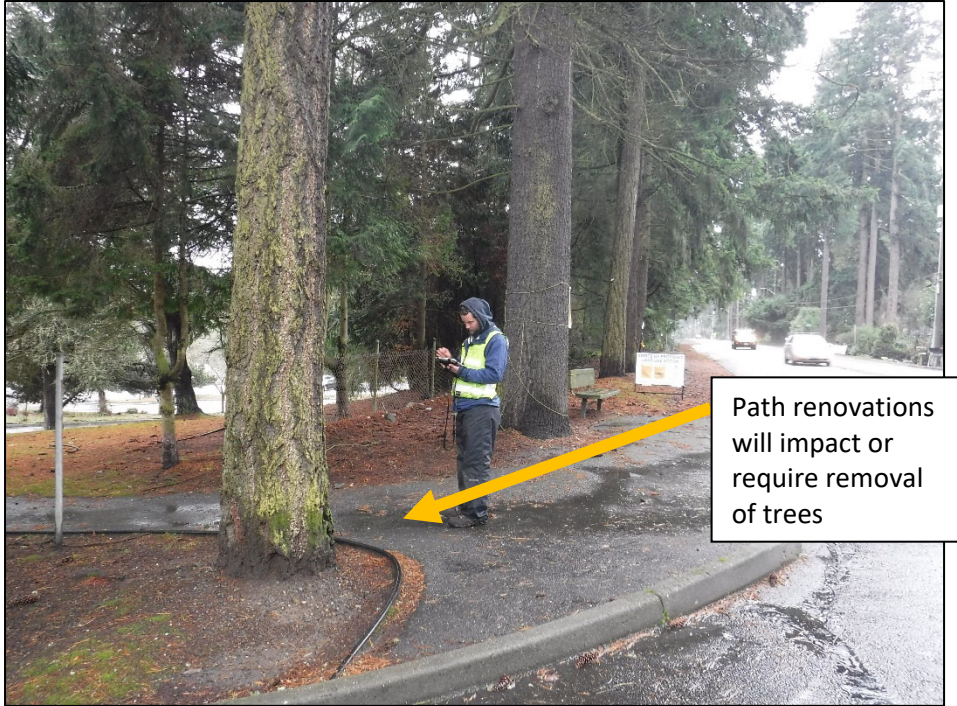
Photograph 3: Looking south along Dayton Ave N

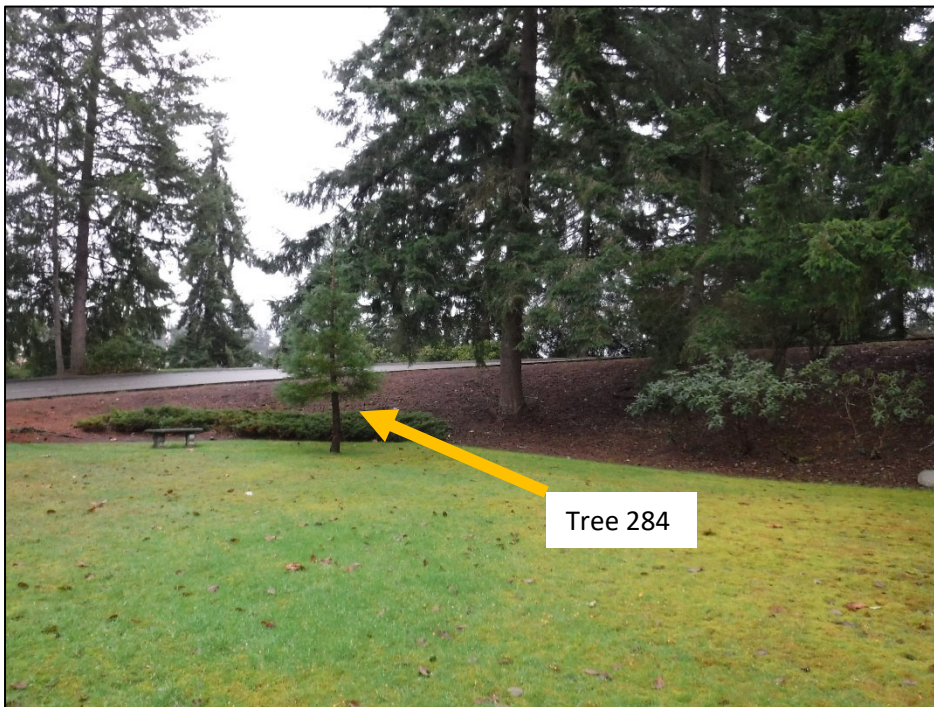
The storm drainage improvements will require a number of trees to be removed. Tree 284 is a 4.1-DSH giant sequoia (*Sequoiadendron giganteum*) in good health and structural condition. This tree is young and a good candidate for transplanting to another planting location on the site (Photograph 4).

Photograph 4: Looking at the future storm drainage area.

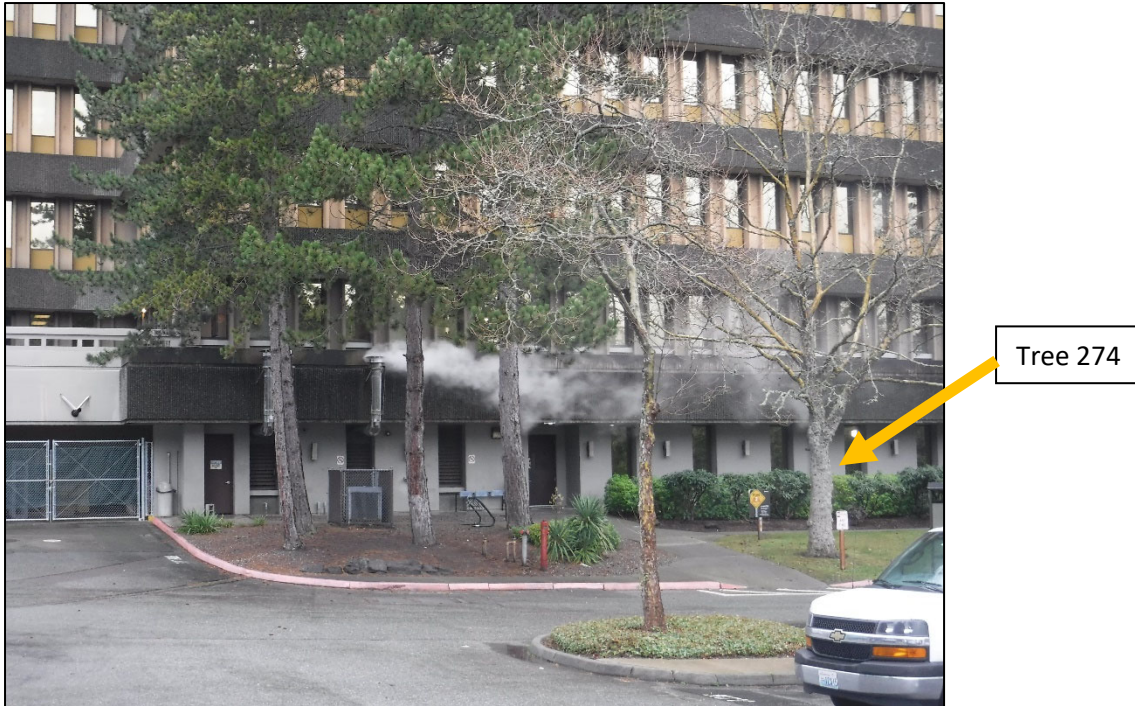
Tree 274 is a London planetree (*Platanus x acerifolia*) in good health and structural condition that is in close proximity to path renovations. Based on the plans the path location is moving to the west through a grove of pines. Tree 274 could be retained if the existing hardscape is carefully removed. It should be removed from north to south and immediately covered with 4 to 6 inches of woodchips to protect the soil from compaction and desiccation or damage to any roots that were exposed.

Photograph 5: Looking north at the trees in front of an entryway. The path is proposed to be redesigned. Tree 274 may be able to be retained if existing hardscape is carefully removed and covered with coarse arborist woodchips.
