DRAFT Arborist Report

Assignment & Scope of Report

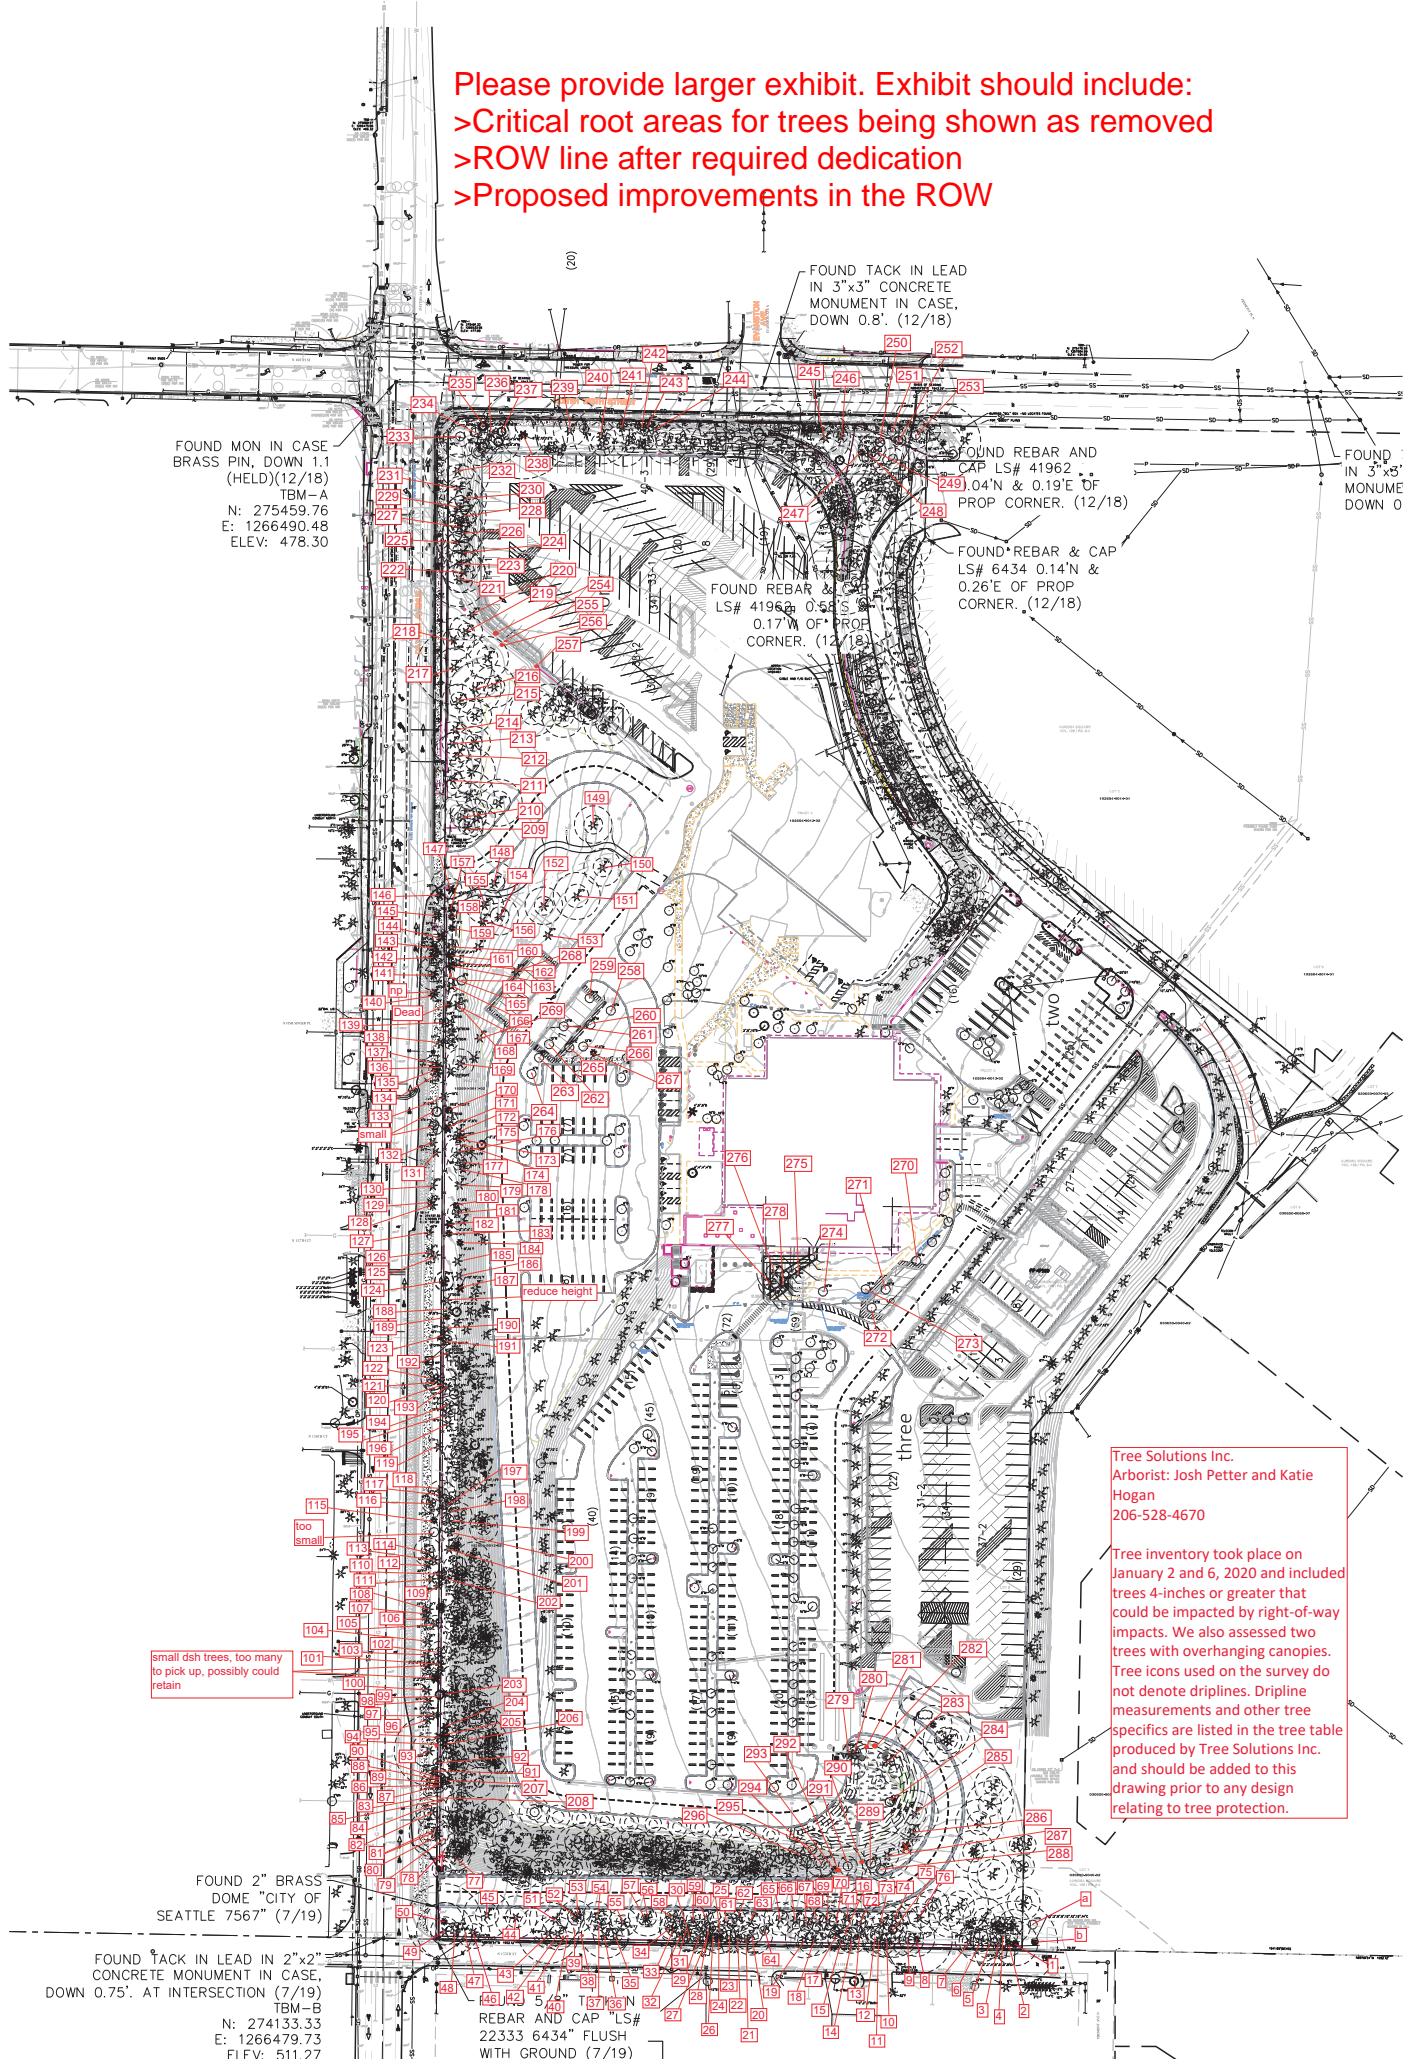
Tree Solutions Inc.
Arborist: Josh Petter and Katie Hogan
206-528-4670
