Site Visit Report completed by Ryan Odegaard.

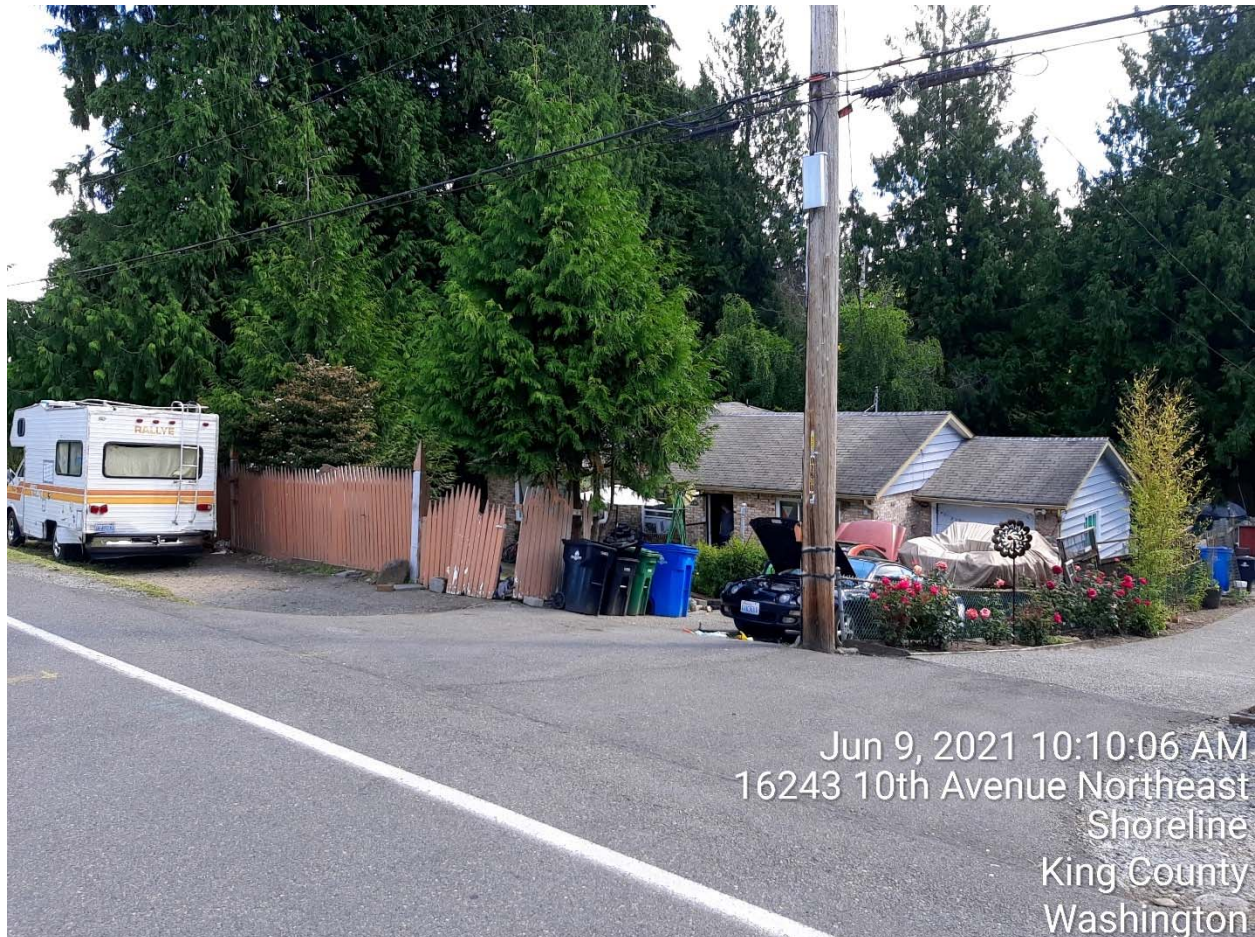
This is a street view photo from the south of the property to the north. The color of the home is Blue with a yellow trim. The home is a single-family home with a basement. Attached to the home is a single garage located on the south side of the home/lot with a single driveway that is sloped. The exterior of the home that divides the city right of way and private property is a fence. The fence in place is chain link, however attached and propped up on to the chain link fence are wooden sections of lumber (color is brown). The materials used are to limit public view to the home and are defined as refuse until properly used and constructed as a fence. The approach to the home is only through the paved driveway as the fence materials are broken, unsecured and have nails and construction materials attached that can cause harm to a person entering the property and/or working in the ROW. The homeowner obtained the materials from another home site approximately two years ago brought to his home as to add more privacy.

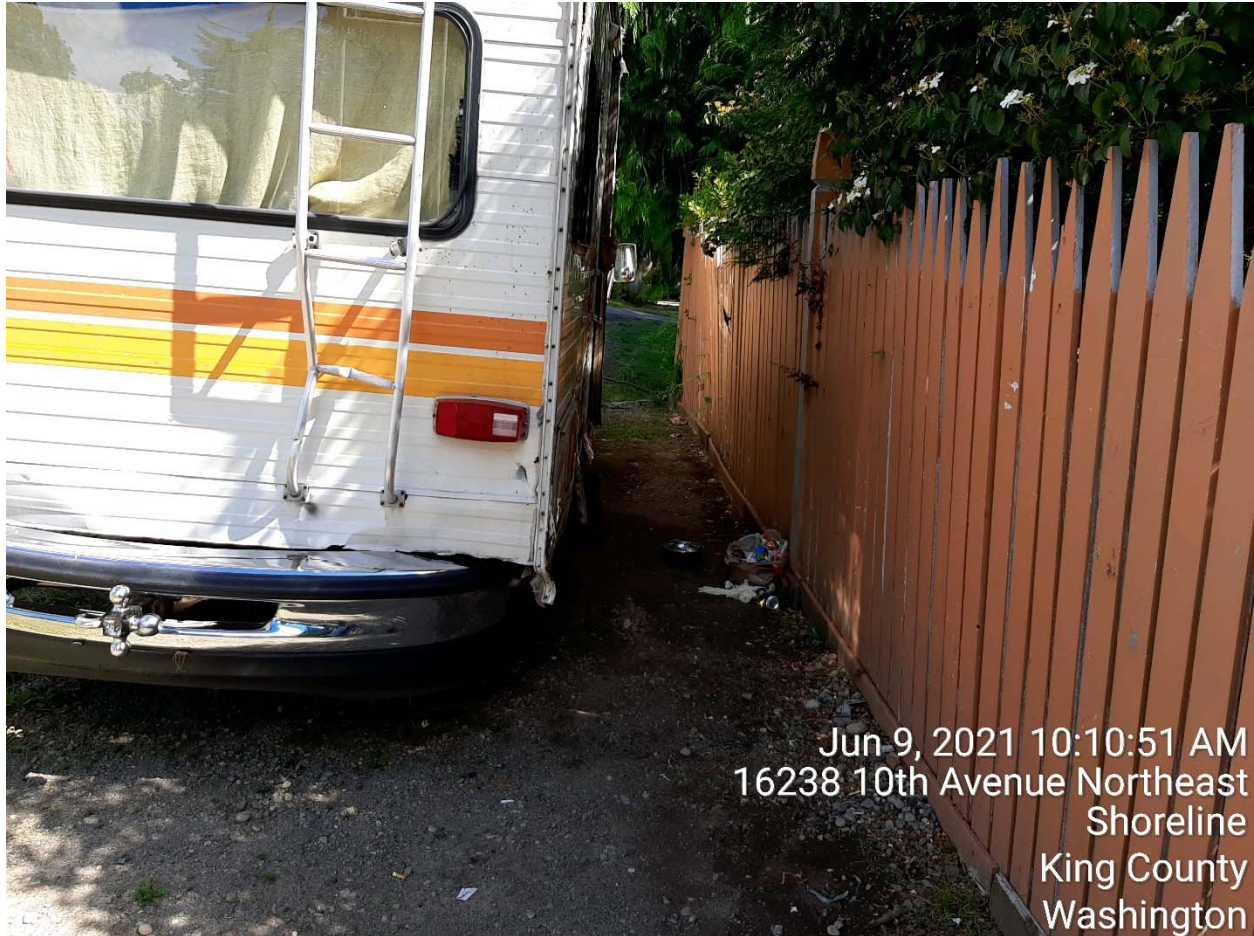
Located in the photo above is debris as defined by the homeowner as being left by the tenant of the recreational vehicle. The homeowner advised that the residence does not have garbage service. Located on-site are garbage cans, however the homeowner does not pay for garbage and refuse service due to prior lack of payments and his account has been suspended by Recology.

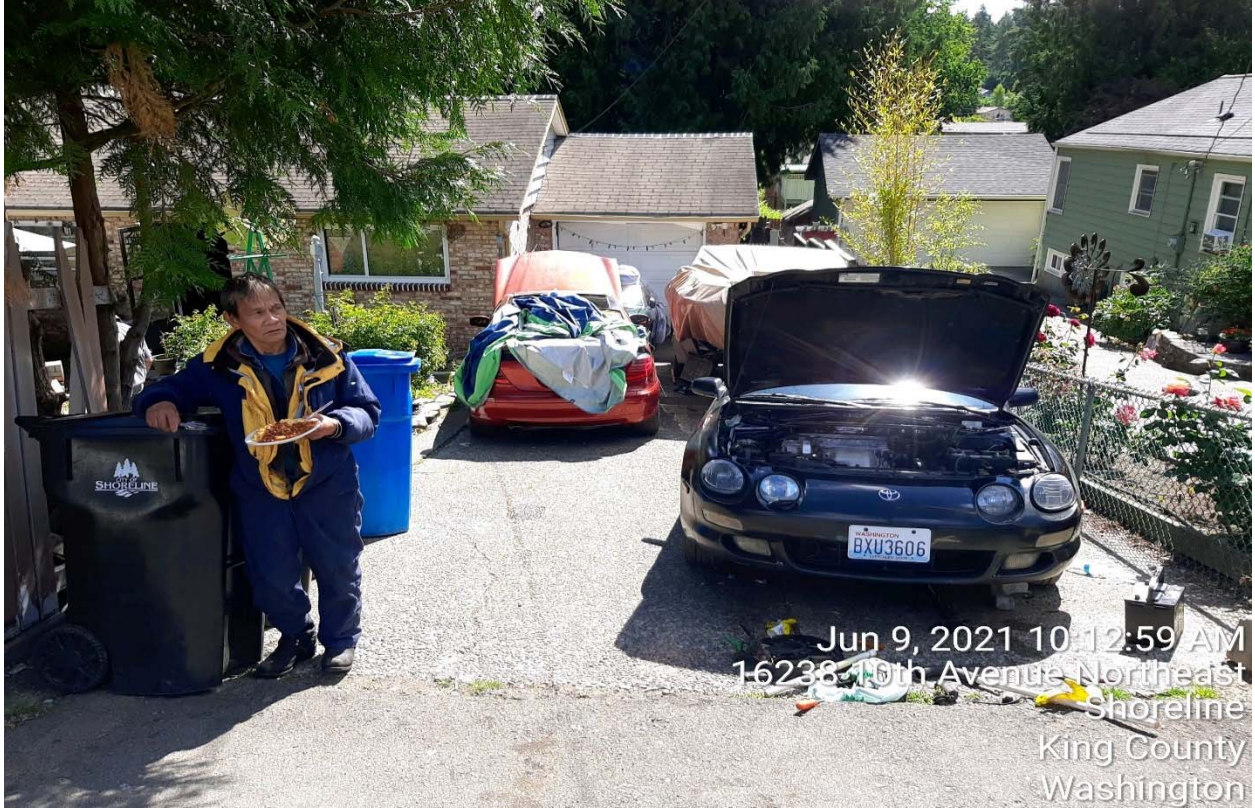
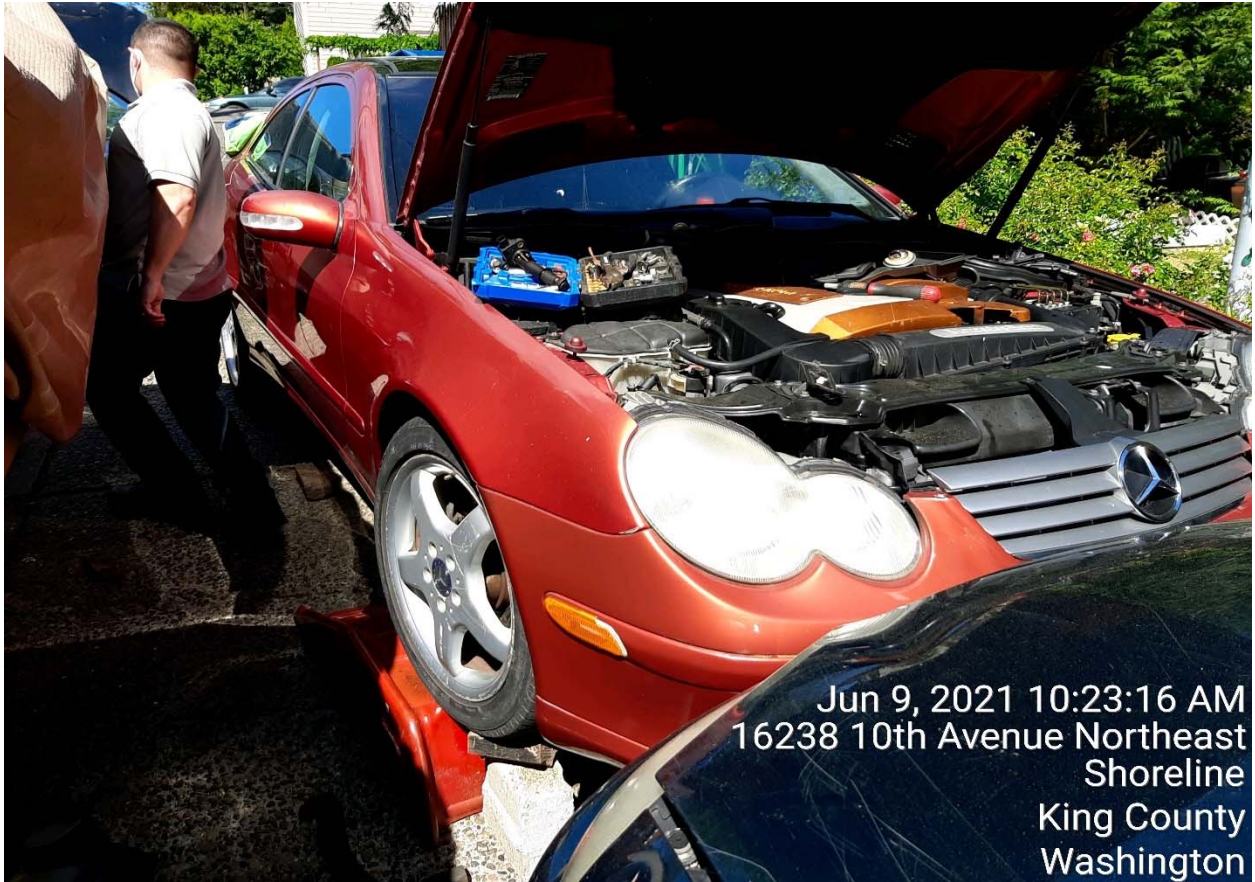
During the time of the visit the homeowner was actively working on a vehicle with an unknown man. The man was defined as a friend and tenant by the homeowner. The vehicle that was not operational at the time was a Toyota.

Also in the driveway were non-operational vehicles noted as a red Mercedes and green Mazda coupe. Both vehicles are damaged and covered with debris and/or tarps. The driveway also contains a Reinell inboard/outboard boat on a trailer. The boat is not operational and is covered by a tarp.

The driveway has motor vehicle parts lying on the ground to include radiator, car batteries and exhaust systems. Tools used to work on vehicles are also located in the driveway, much of the tools are rusted due to being left in the driveway overnight and/or in the outdoor weather environment.

The garage door is not functional and is broken. During the visit today it was closed with materials propped upon each side. During prior inspections it was reported that the garage had been occupied as a living space and storage space. I was informed that it was being used as storage space currently.

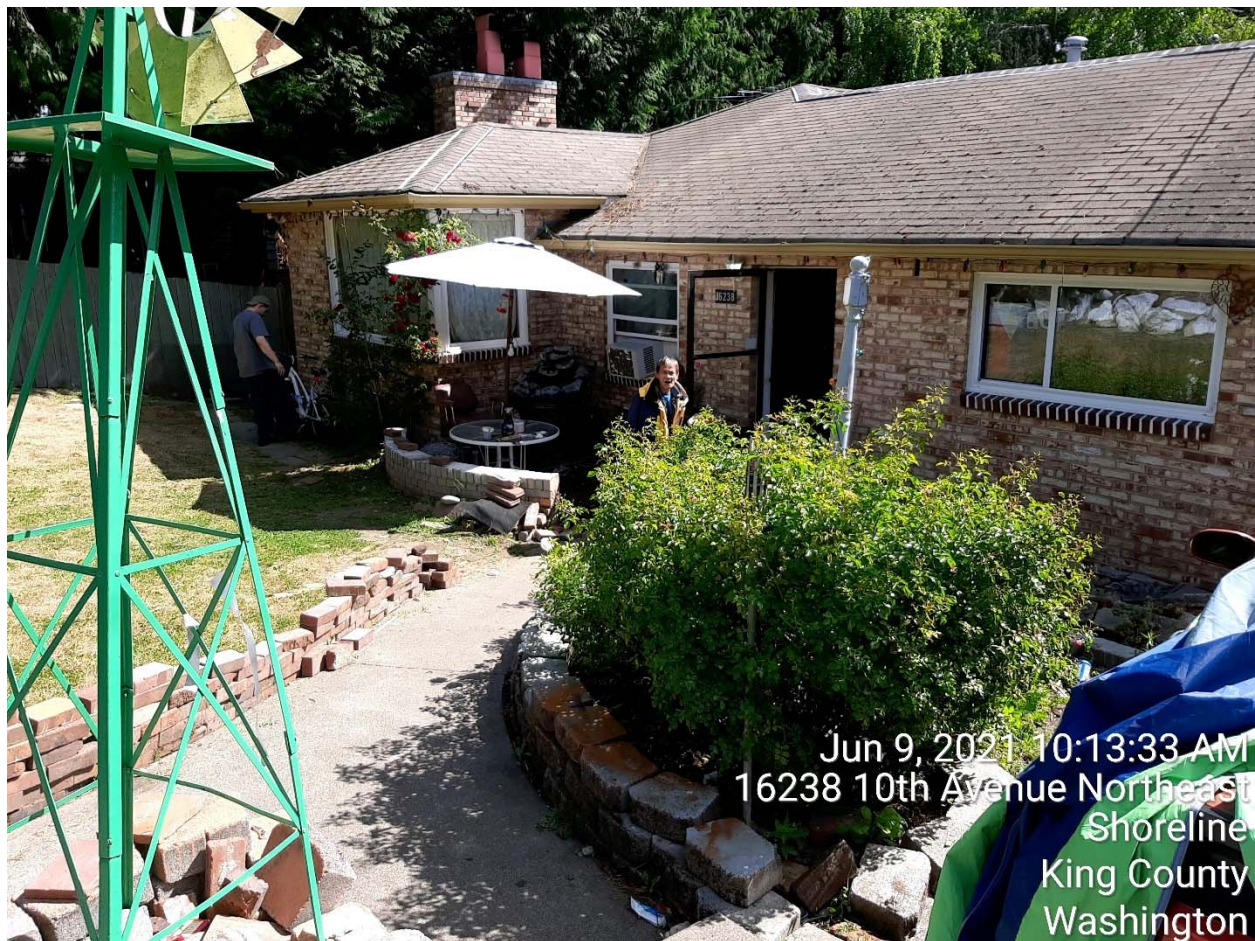
The approach to the home from the driveway is lined with stacked masonry red brick that are not secured by mortar. Some brick and landscape blocks are safely stacked and others are not. The entrance to the home is cleared and houses a decorative patio table.

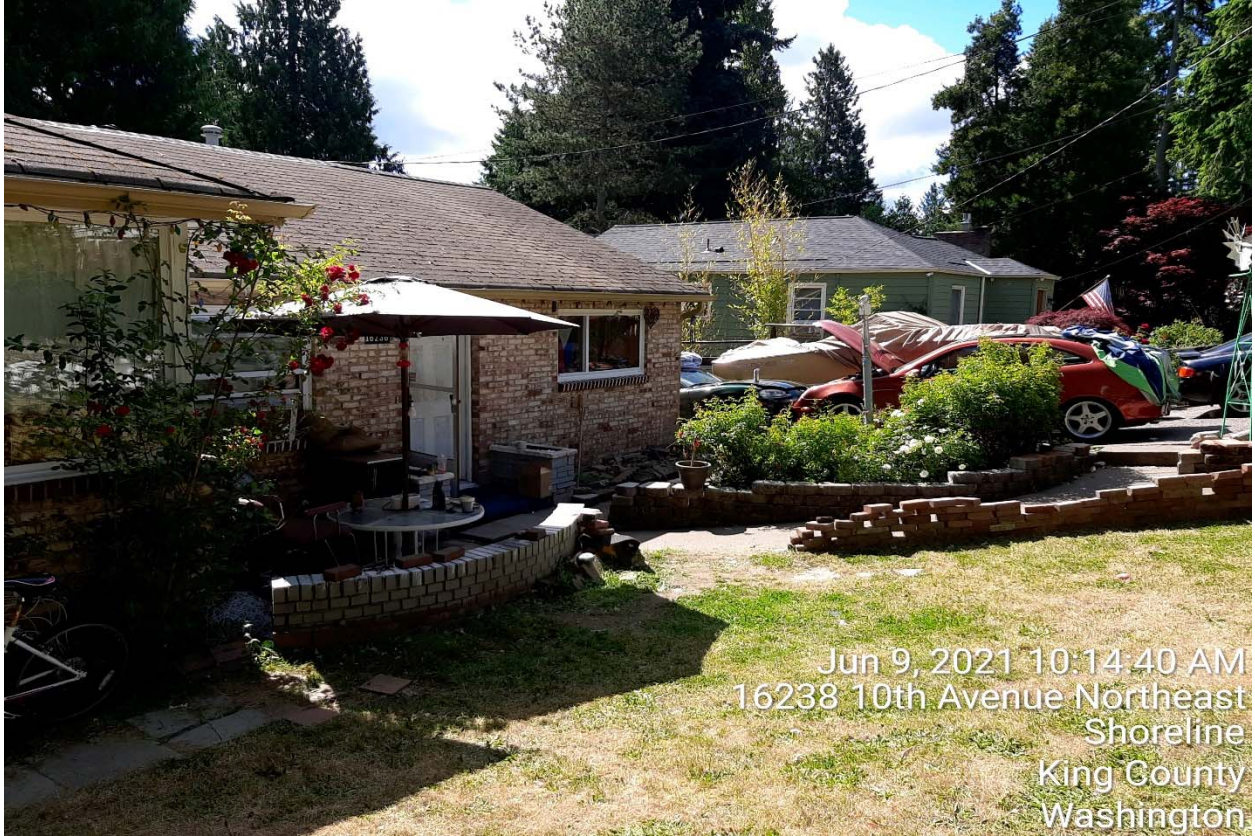
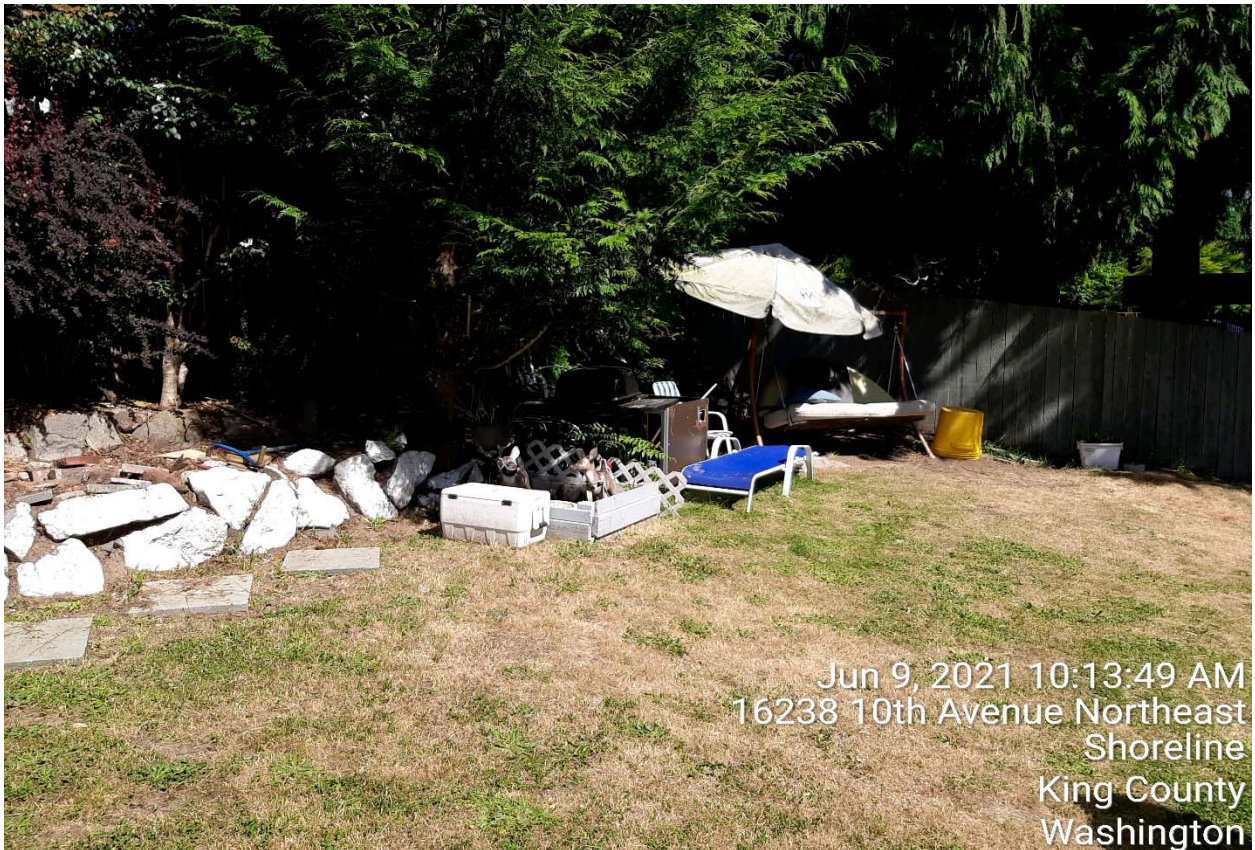
Located in the front yard is a barbeque, old rusted metal object, cooler, lawn furniture, yellow garbage cans (stacked) and outdoor living swing and patio umbrella. This area has functional items that would not be defined as refuse. It is noted that this area of the property is improved.

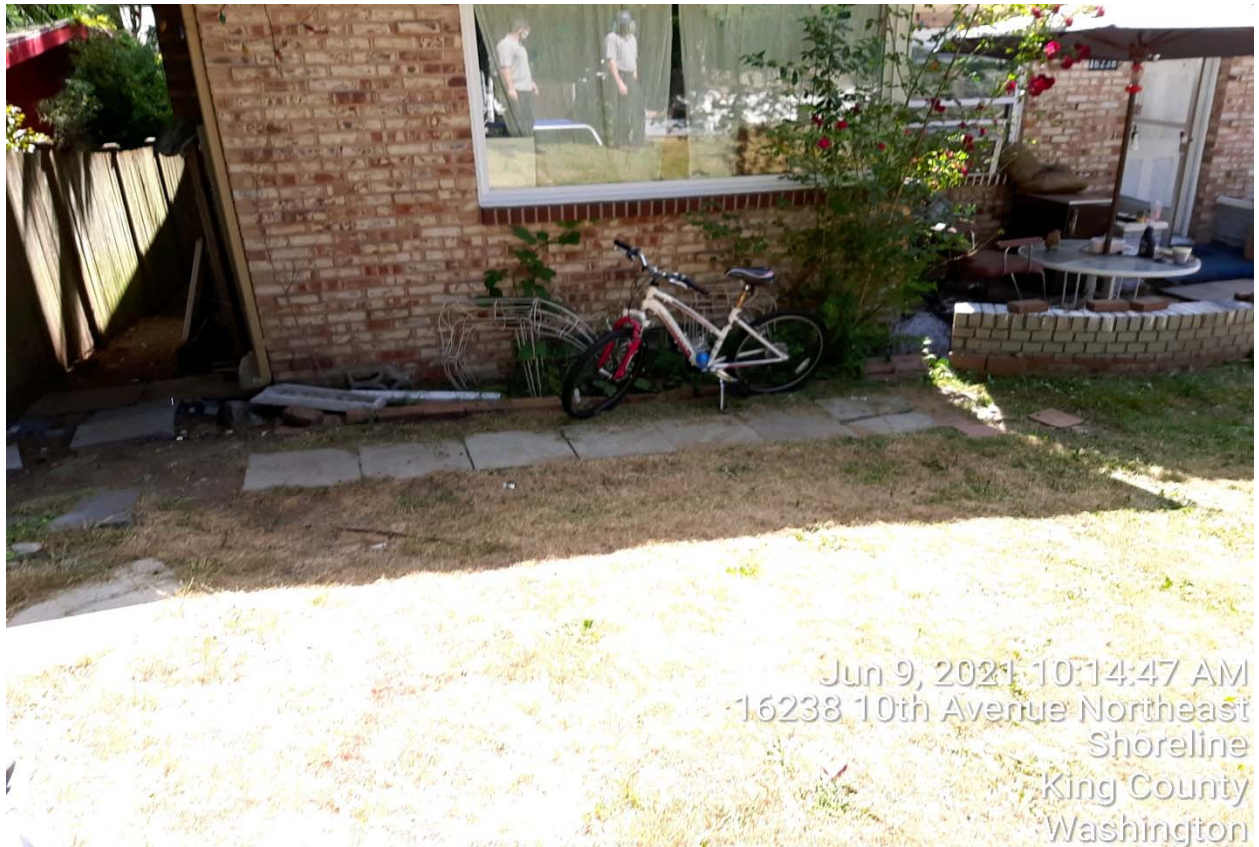
Jun 9, 2021 10:14:47 AM  
16238 10th Avenue Northeast  
Shoreline  
King County  
Washington

The window located on the northside of the home is broken and leads to the basement living area. This window has been broken and not repaired. I was advised that the old table in the photo was used to prop up against the broken and damaged window.

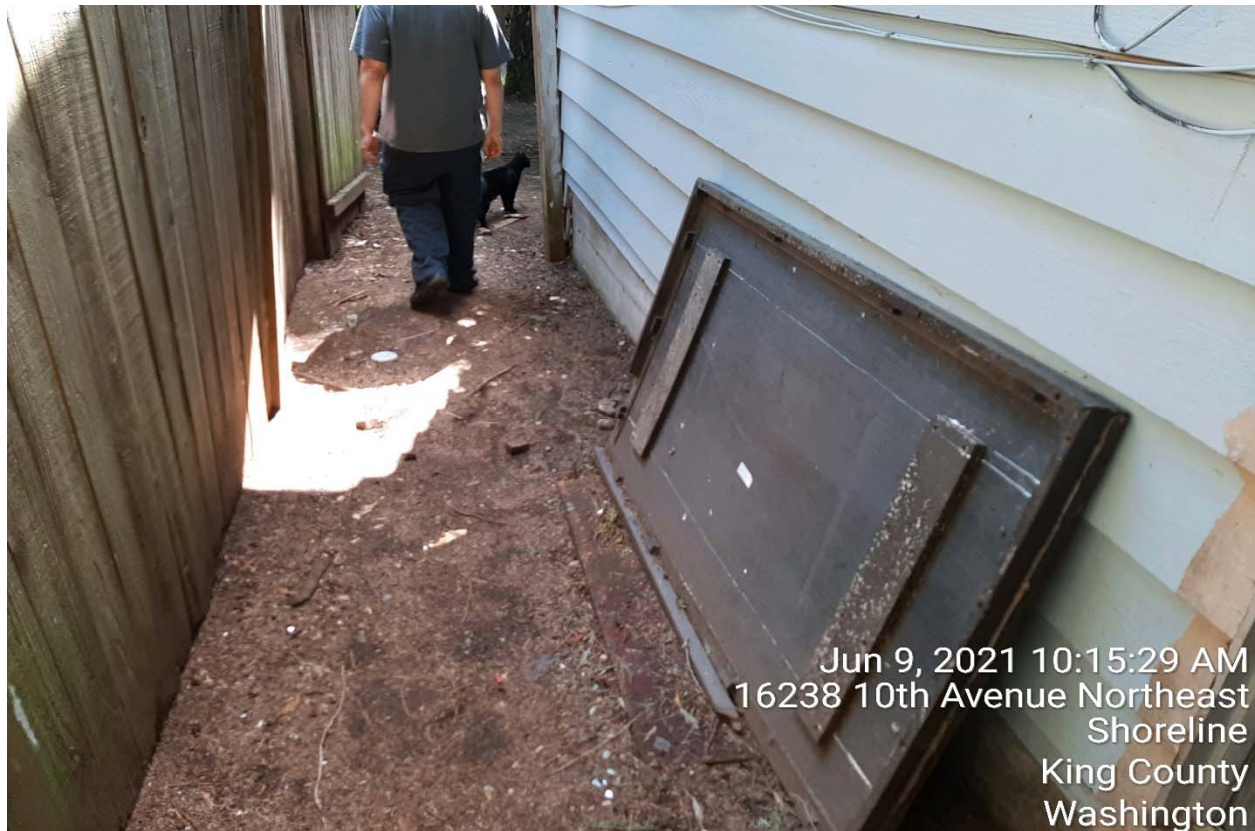
The site visit continued by entering into the backyard from the northside of the property. Upon entering the backyard the home has a deck attached to the east side of the home. The deck is raised and has storage under the deck. This area has materials that are defined as refuse.

The deck is being used as an outdoor living area for persons living at the home. You can see that there is a tent, tarps, furniture established on the deck. Rio informed me that the persons living on the deck are residents that are homeless. The names of the occupants are unknown to Rio.

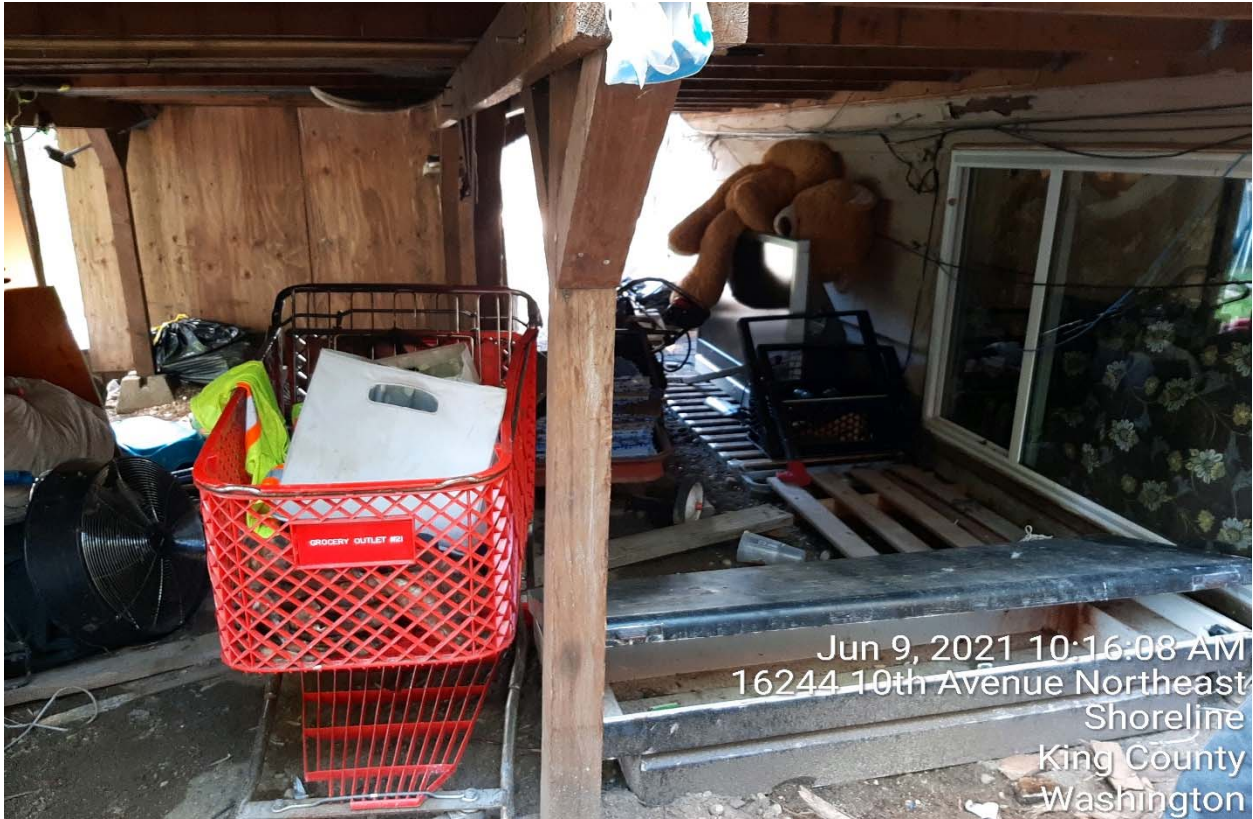
Jun 9, 2021 10:16:08 AM  
16244 10th Avenue Northeast  
Shoreline  
King County  
Washington

Refuse is grocery cart, kids toys, fan, garbage bags filled with refuse and unknown personal property, wood materials. The photo above is of the items under the deck. The refuse continues as the residents bring items to the home. It is noted that this area was cleaned with prior refuse vouchers provided by King County, however new materials surface with new visits.

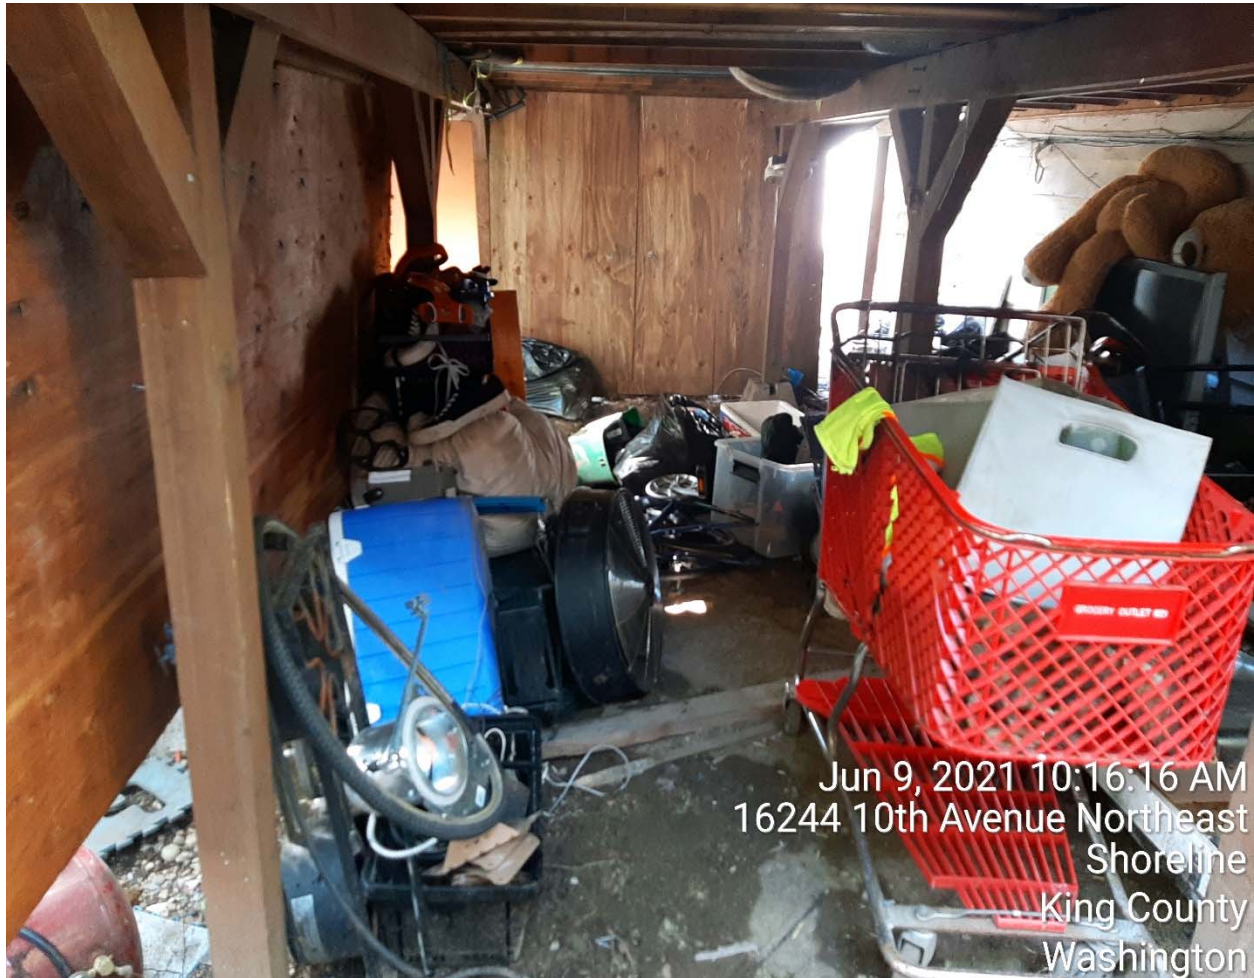
Additional items of refuse are paint cans, green metal storage locker, books, propane tanks, clothing, workout/gym equipment and tools.

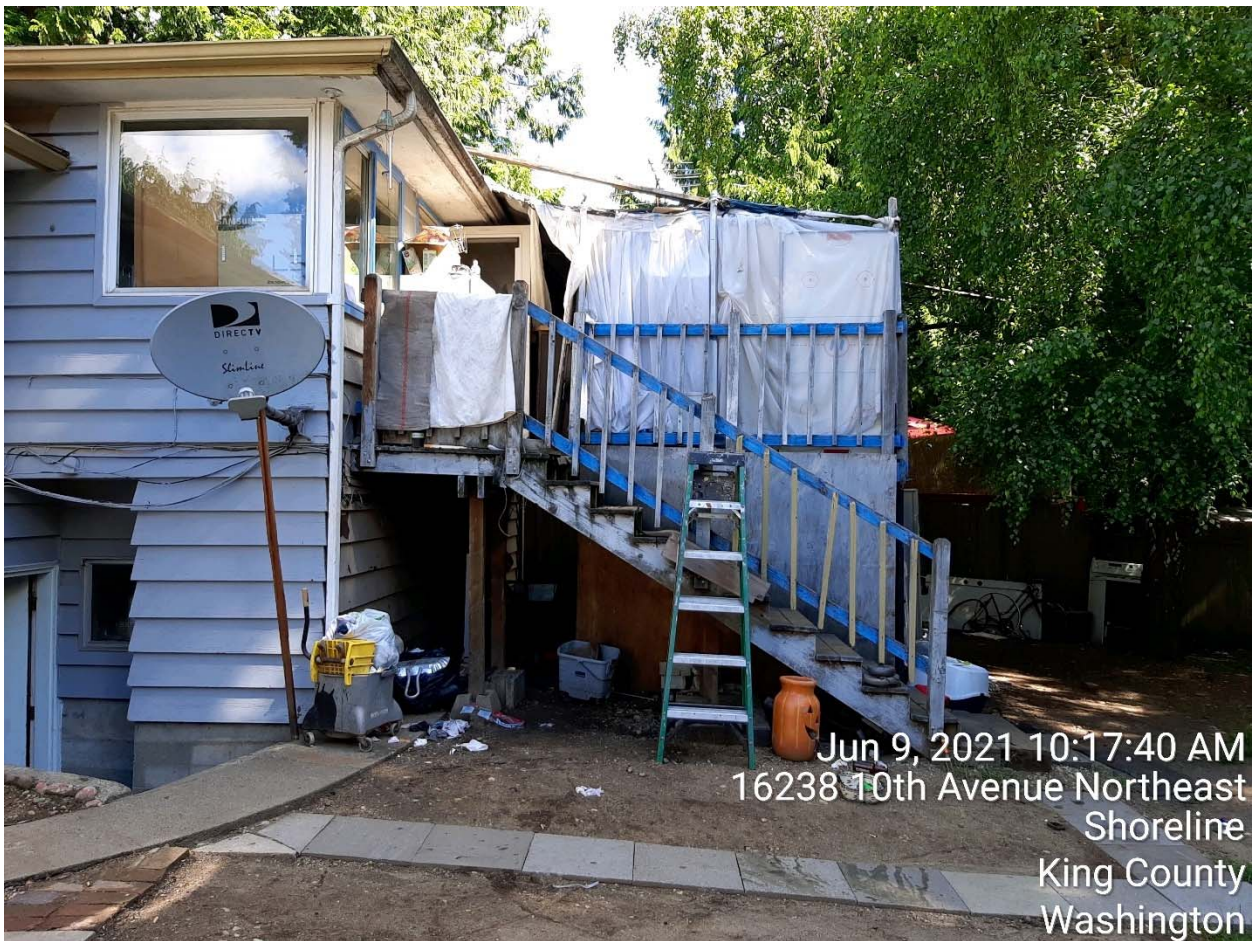
The below photo is of the outdoor shelter established on the deck.

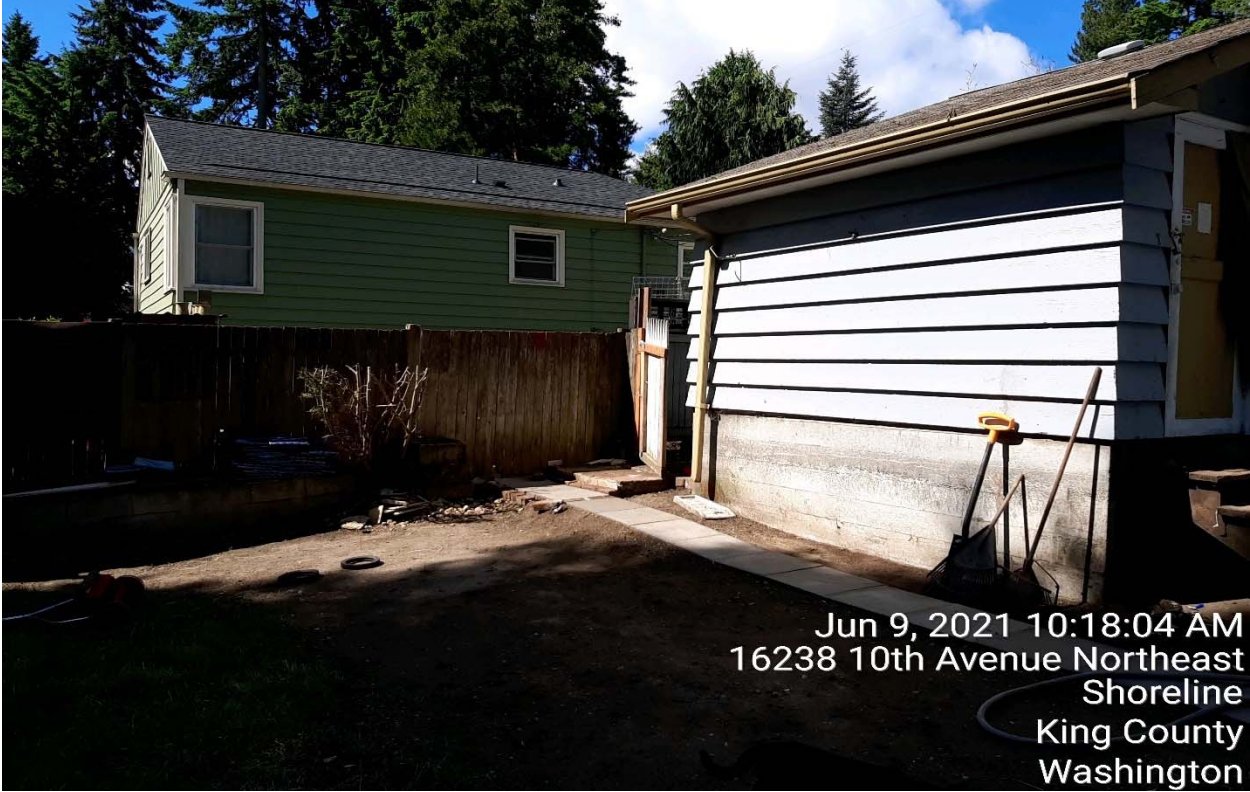
Extending into the backyard is a grass area. The grass area has a large burn pit where refuse is burned. Also in this area is an outdoor laundry line. This is the area where the Shoreline Fire Department has responded to calls for service due to burning refuse. Dividing the backyard is a large green fabric silt fence. Beyond the fence is refuse, outdoor play structure and two outdoor living areas. The green fabric fence was put in place to provide the outdoor residents more privacy from the neighbors.

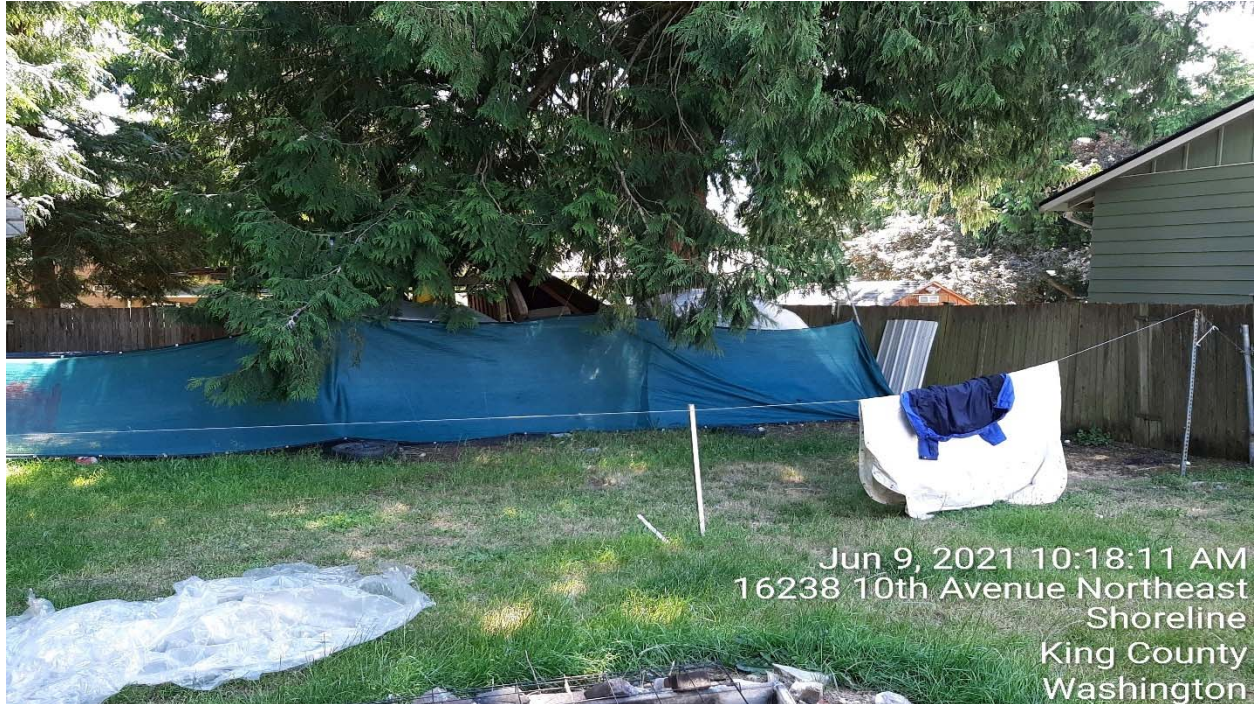
Glass, metal piping and wood materials defined as refuse.

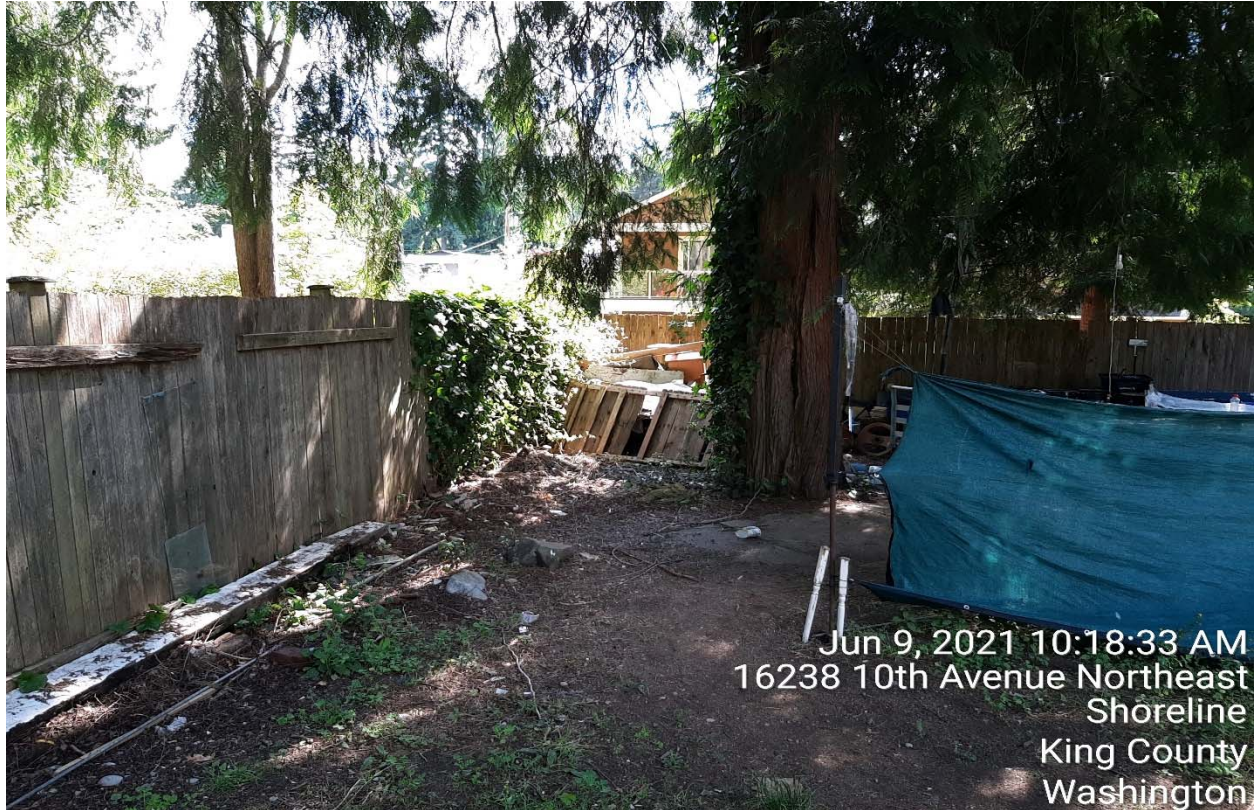
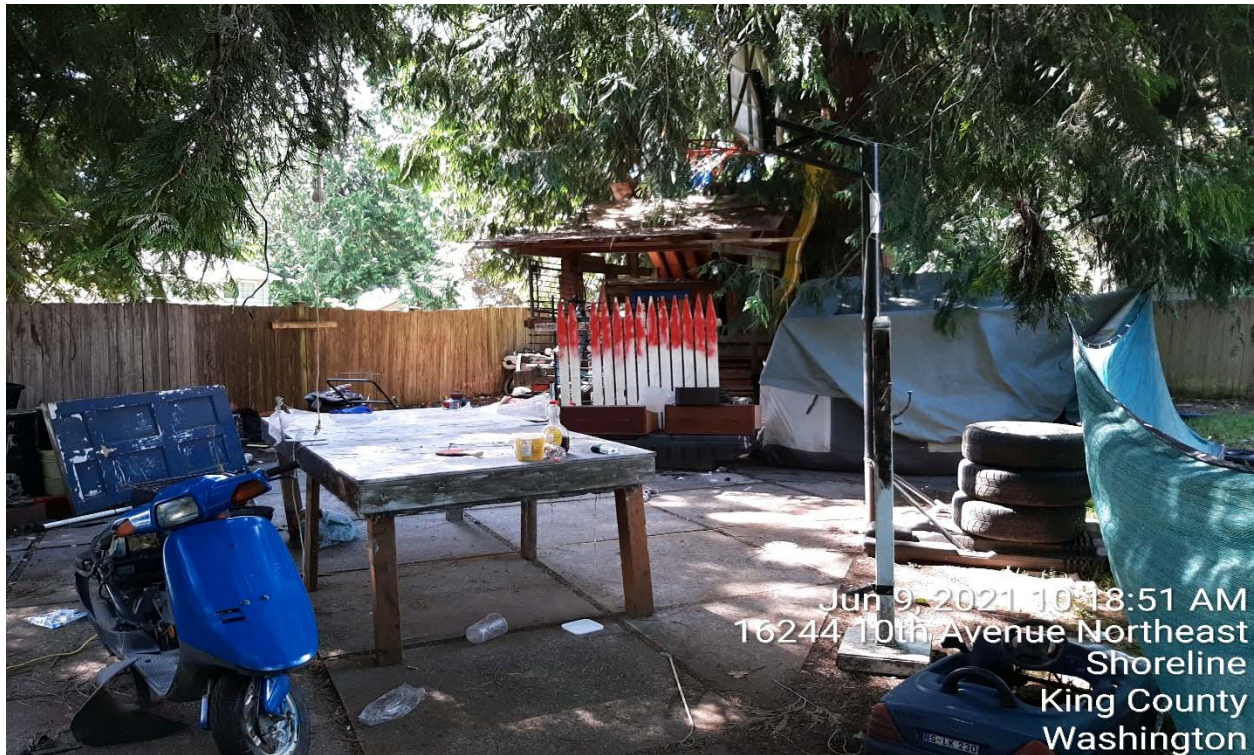
Outdoor living area near two encampments in the backyard. Old doors, tires, food refuse, wood materials, glass, kids toys, non-operational lawn mowers, motorcycles non-operational, car floor mats,

chairs, construction tile, damaged furniture, kitchen appliances, paint, 5 gallon buckets, motorcycle parts.

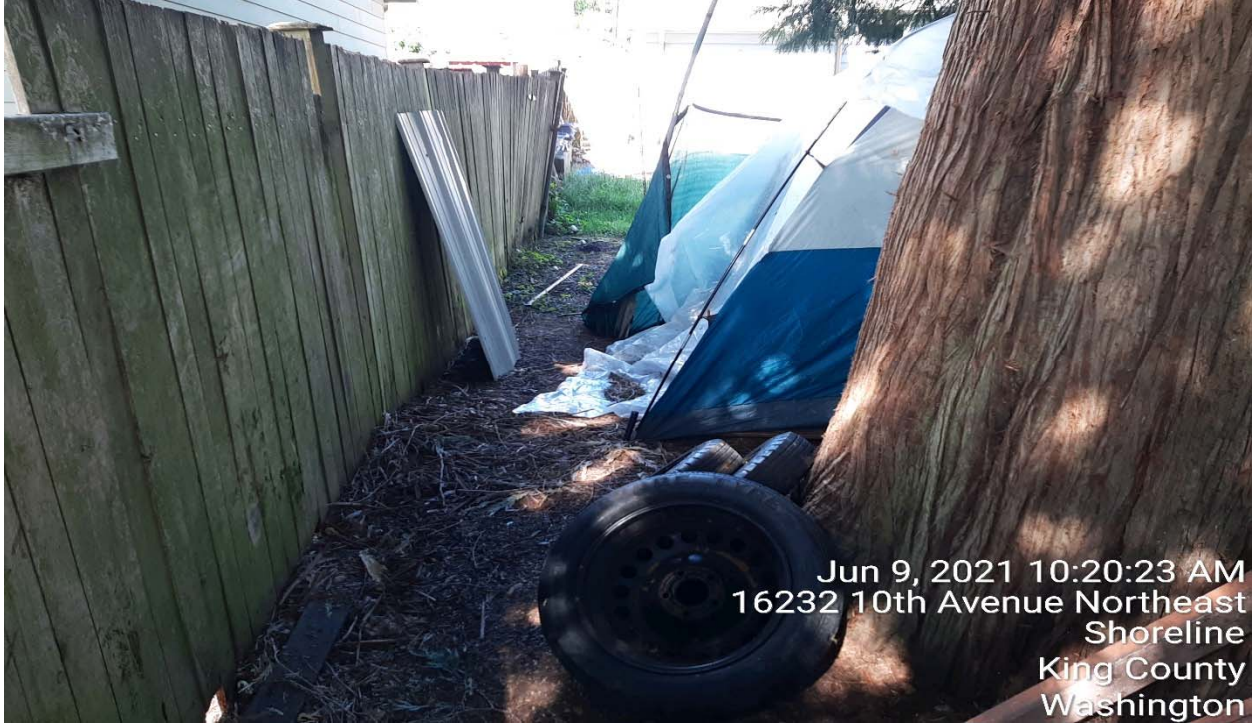
Jun 9, 2021 10:20:23 AM  
16232 10th Avenue Northeast  
Shoreline  
King County  
Washington

Photo below of exterior camping and living entrance. Location is South / East corner of property.

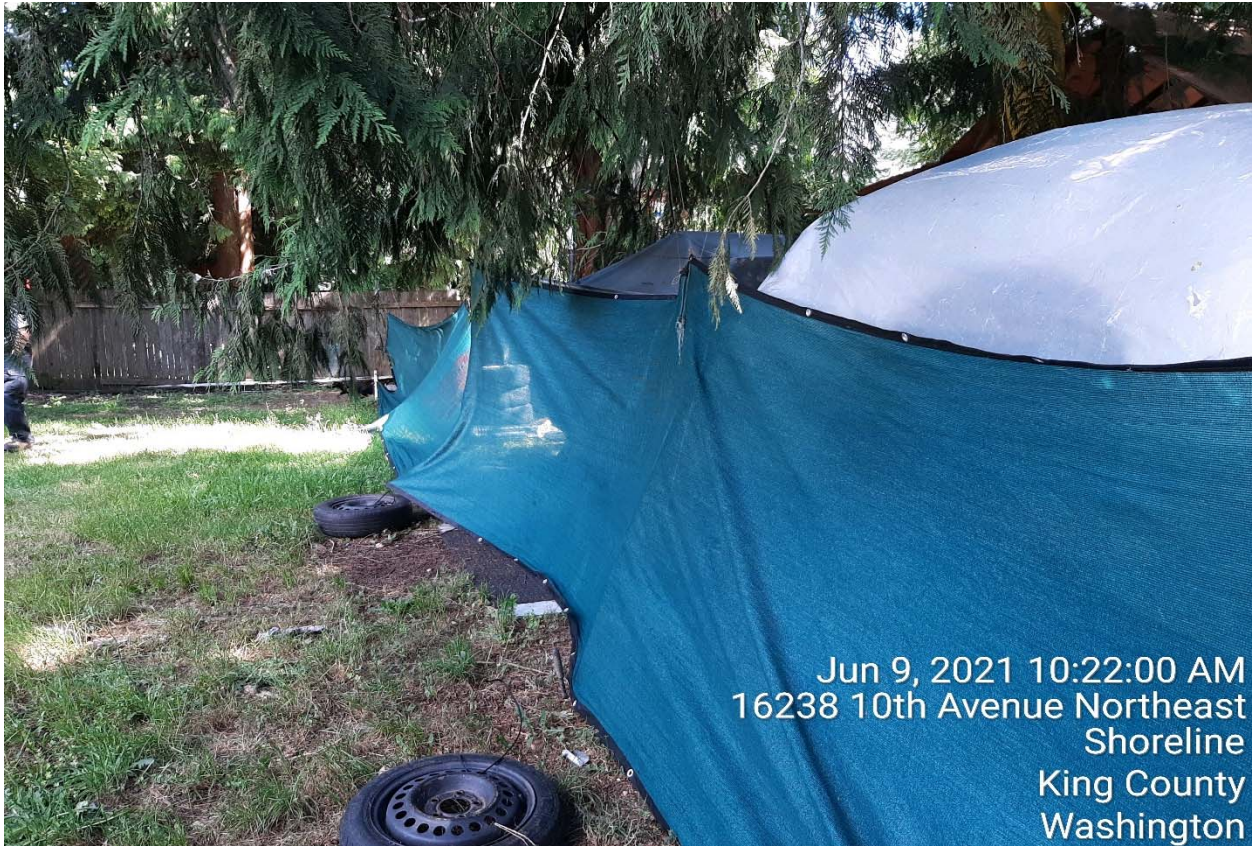
Jun 9, 2021 10:22:00 AM  
16238 10th Avenue Northeast  
Shoreline  
King County  
Washington

Rims, tires, debris and unknown boxes located on east fence and south fence location.
