## **ADMINISTRATIVE ORDER#000110-081909**

### **SITE SPECIFIC CODE INTERPRETATION TC 16, TC 17 AND TC18**

#### **CODE SECTION: 20.80.460 and 20.80.470 Streams**

# **Fircrest Master Plan:** Critical Areas Report and Conceptual Restoration Plan for Hamlin Creek, Shoreline, WA

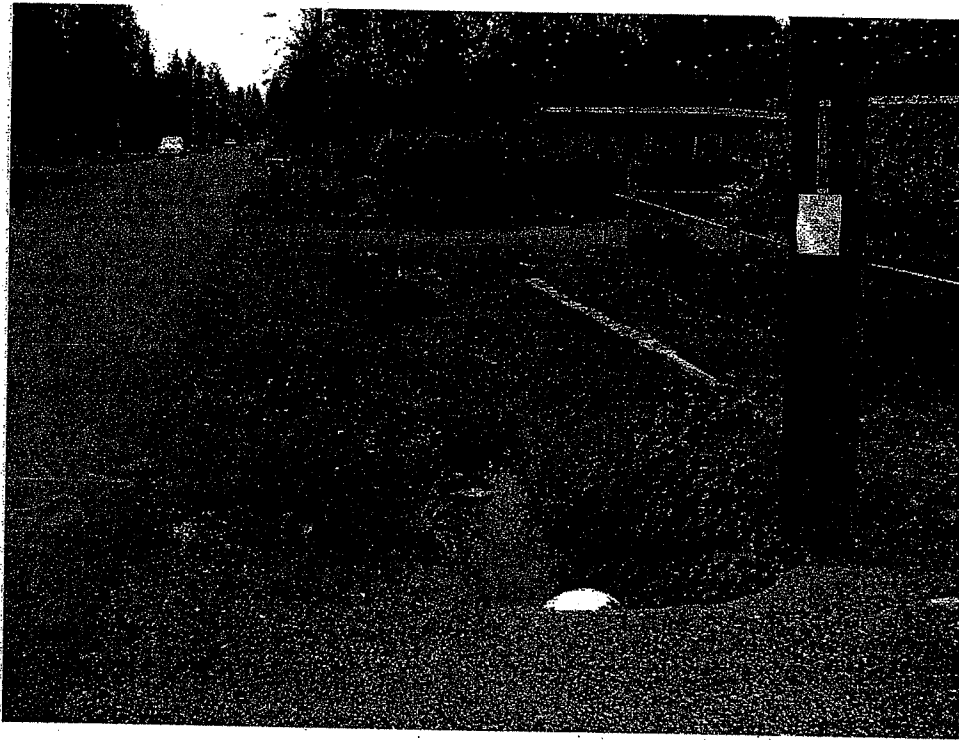
Figure 4. Ditched Hamlin Creek channel along the west side of 20th Avenue NE, downstream of the Fircrest Campus (Taken on 9/17/08).

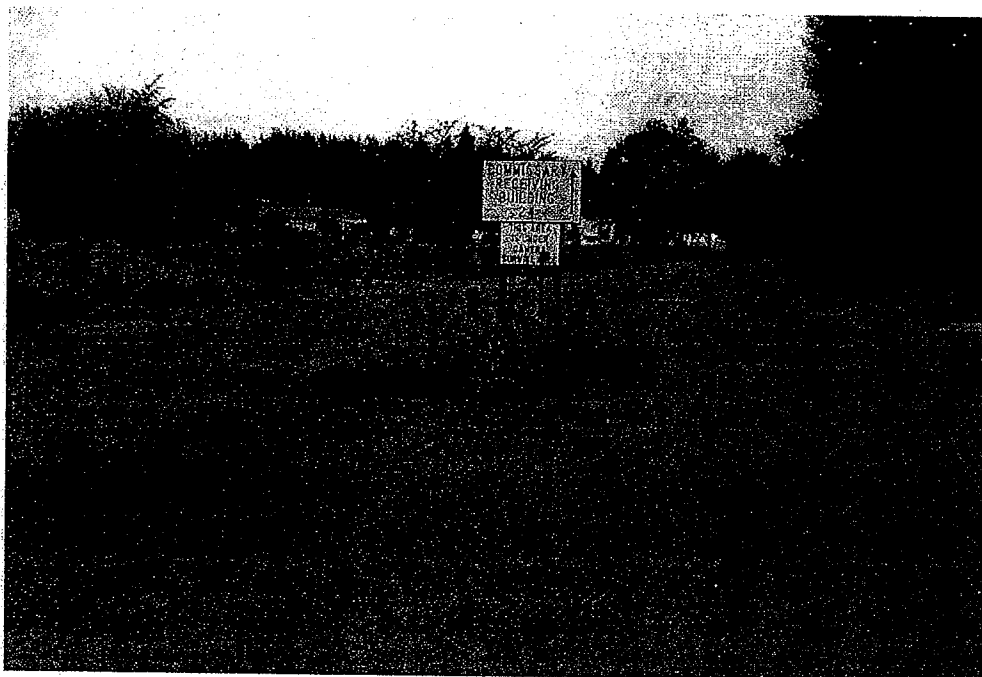
Figure 7. Hamlin Creek Area A stream daylighting area, facing North from near NE 150th Street. Catch basin in foreground locates the confluence of the east and west forks, both of which are currently piped at this location (taken on 9/17/08).

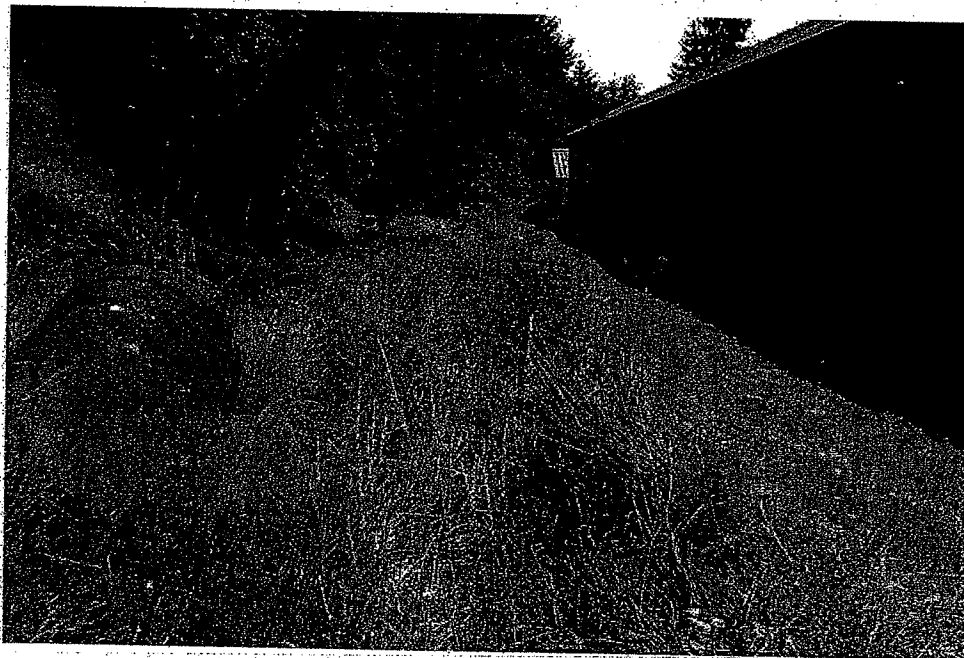
Figure 13. Area B facing downstream. Notice former pipe sections, now removed, and the close proximity of the existing buildings (taken on 8/4/08).

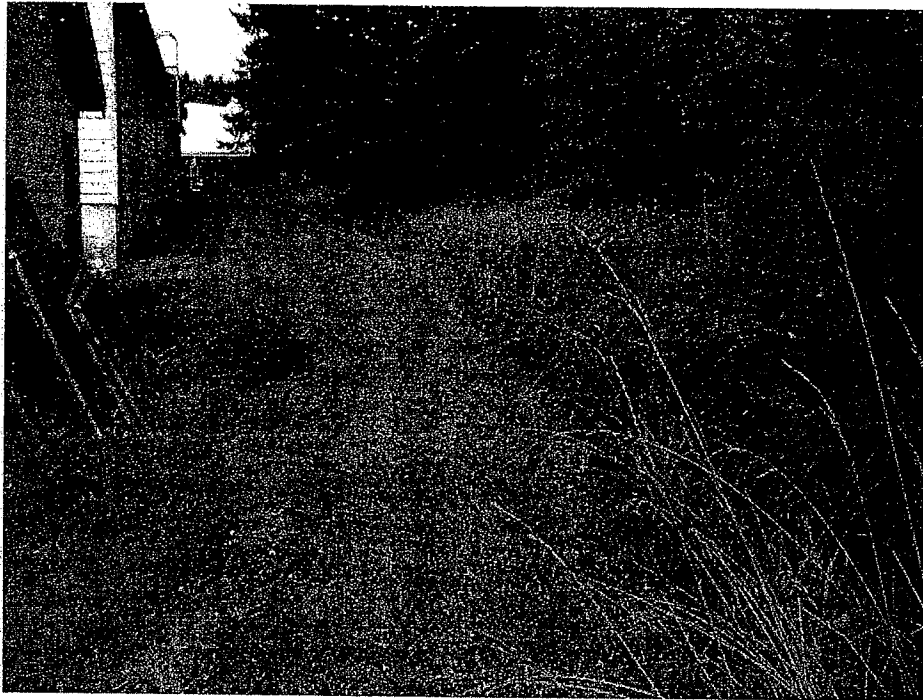
Figure 14. Area B facing upstream. The existing channel is an abrupt, grass-lined ditch. Again, notice the close proximity of the existing buildings (taken on 9/17/08).

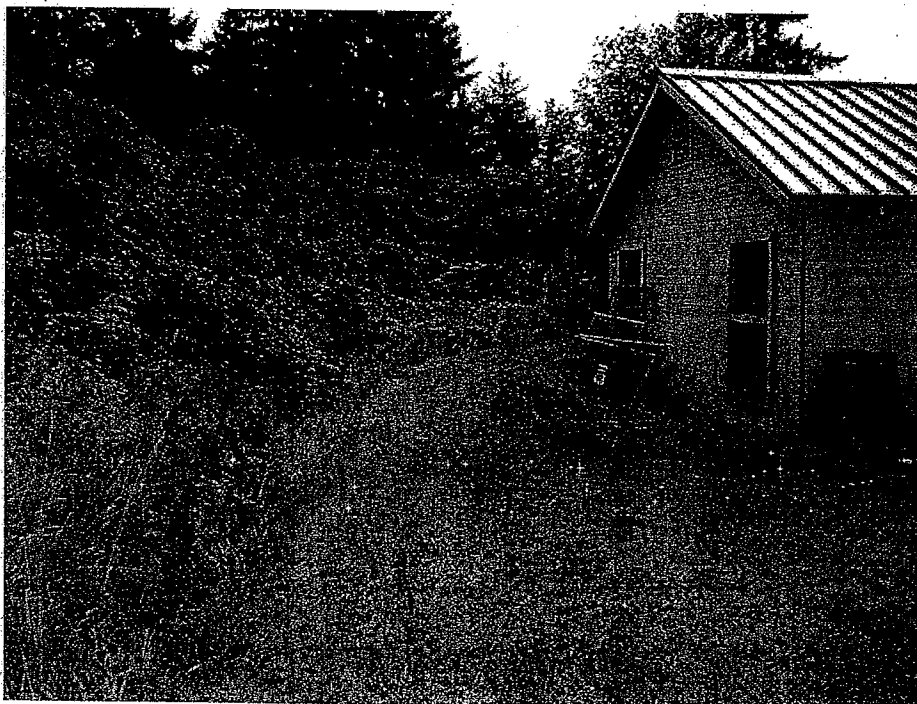
Figure 15. Area B facing downstream near lower end. Note slope vegetated with invasive Himalayan blackberry and morning glory (taken on 9/17/08).

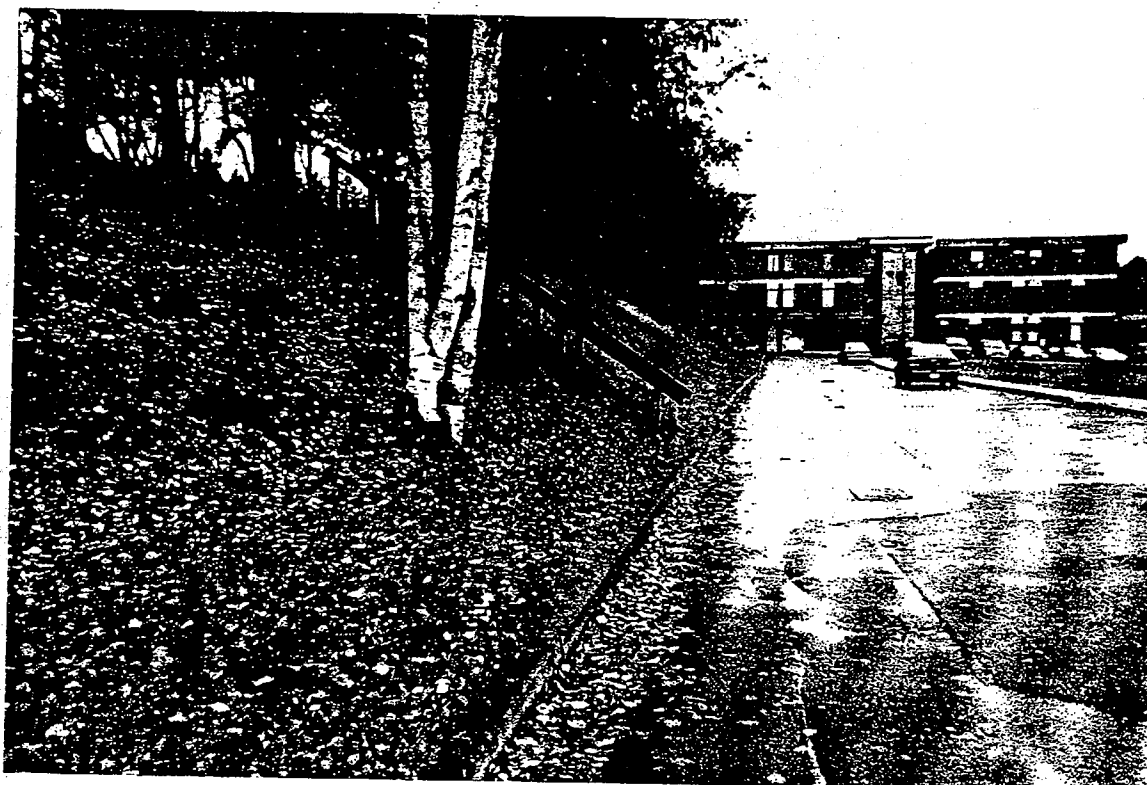
Photograph 2. Steep slope along the eastern side of the ridge at the western side of the site. The view is northeast toward Building 200 from the southern end of the ridge. The slope is up to 40 percent and ranges up to 20 feet, north of Building 200 in the mid-ground. The slope was cut during site development.

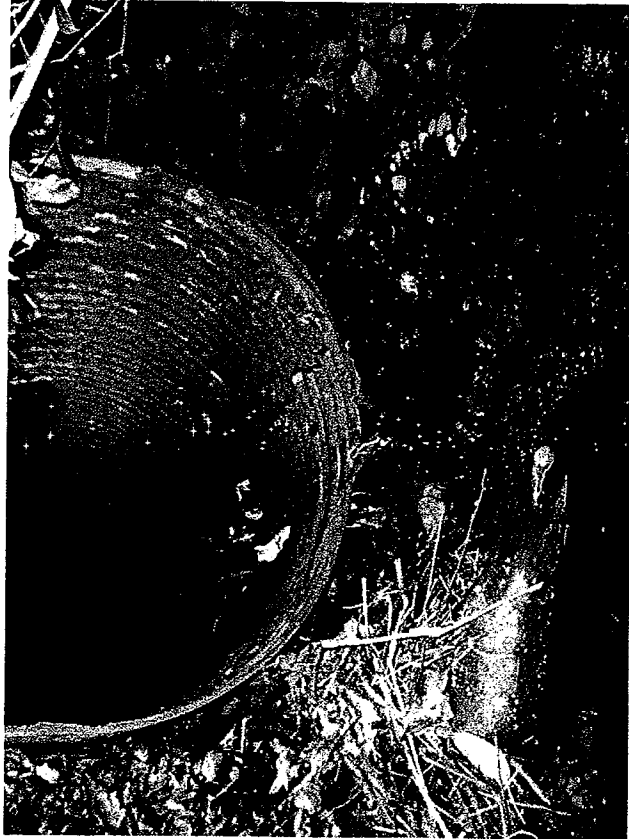
Hamlin Park drainages outfall into Thornton Creek (2-15-09)
