CITY COUNCIL AGENDA ITEM

AGENDA TITLE:	Storm Creek Basin Plan Update		
DEPARTMENT:	Public Works		
PRESENTED BY:	Mark Relph, Public Works Director Jesus Sanchez, Operations Manager Brian Landau, Surface Water and Environmental Service Manager		
ACTION:	<input type="checkbox"/> Ordinance	<input type="checkbox"/> Resolution	<input type="checkbox"/> Motion
	<input checked="" type="checkbox"/> Discussion	<input type="checkbox"/> Public Hearing

FINAL DRAFT MEMORANDUM

Subject: Erosion in Lower Storm Creek

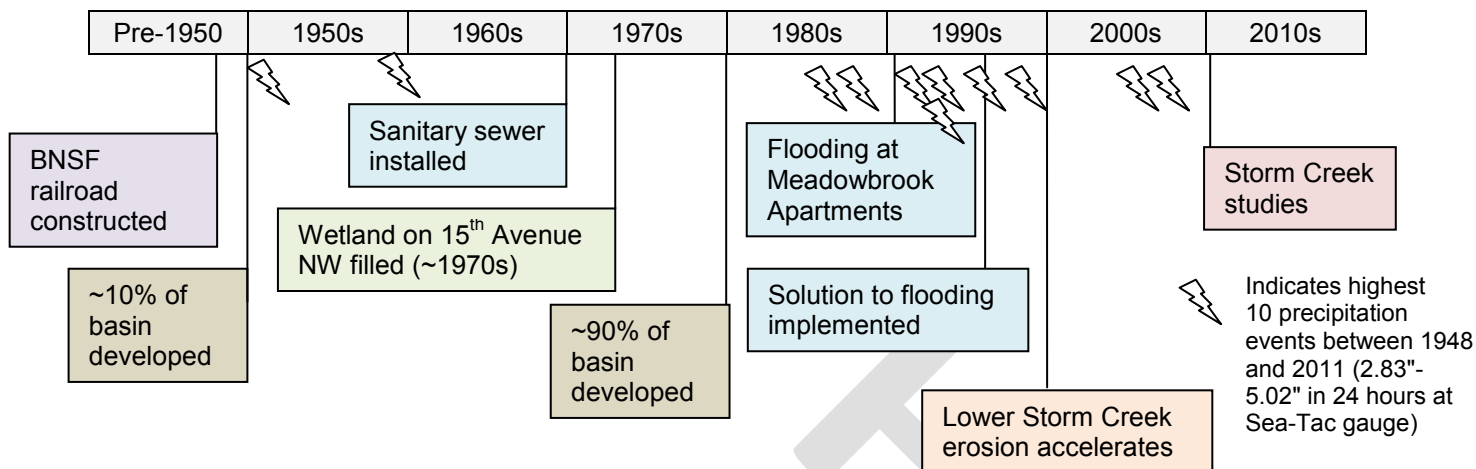
Figure 1. Timeline of events relevant to Storm Creek Basin

In the assessment of Storm Creek, several previous studies, investigations, photos, and maps were reviewed to better understand the historical conditions and potential causes of the erosion that is now being manifest. A list of these documents and their general findings are presented in Table 1. A timeline for various events relevant to the Storm Creek basin are identified in Figure 1.

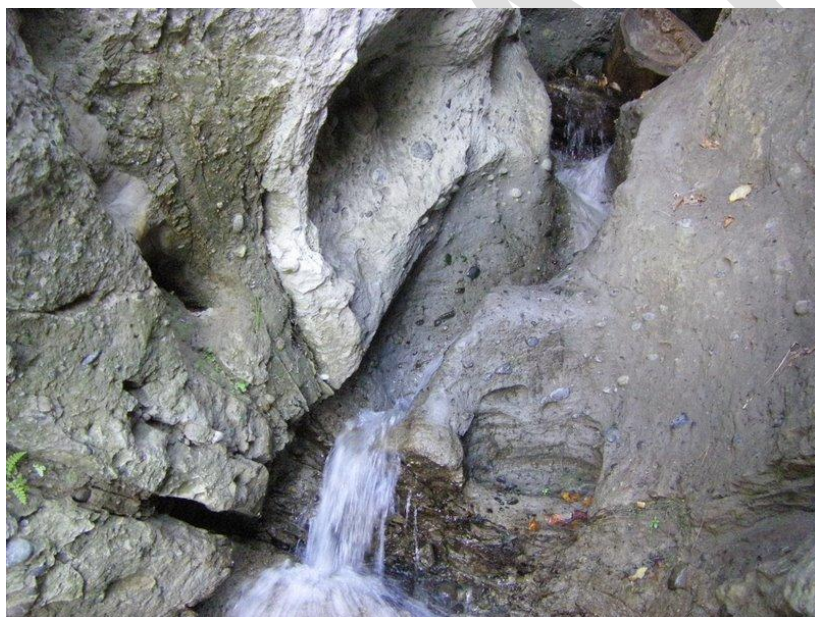
Figure 2. View of lower Storm Creek in the canyon reach, showing a portion of the steep reach about 100 ft upstream of the railroad tracks

The longitudinal profile of Storm Creek has a natural break in slope, approximately at the location of the 17th Place NW crossing. Above this point, the stream flows in a moderately confined upland channel at an average gradient of about 3 to 4%, which is typical for lowland streams in this general topography. Below the road crossing, the bed steepens abruptly, with an average gradient of almost 30%, and includes short reaches of near-vertical falls interspersed with short, relatively flat reaches (Figure 2). In general, such a slope is not stable over the long term and will continue to seek a lower course with a flatter gradient. This process is now occurring on an annual basis along the lower reach of Storm Creek. As the bottom of the channel has lowered, the canyon sidewalls have become progressively higher and steeper, and they, in turn, have begun to fail by landsliding, which serves to flatten their angle and regain a stable slope. This can only be accomplished through a widening of the canyon across its top, with attendant risk to developed upland properties on both sides of the canyon.

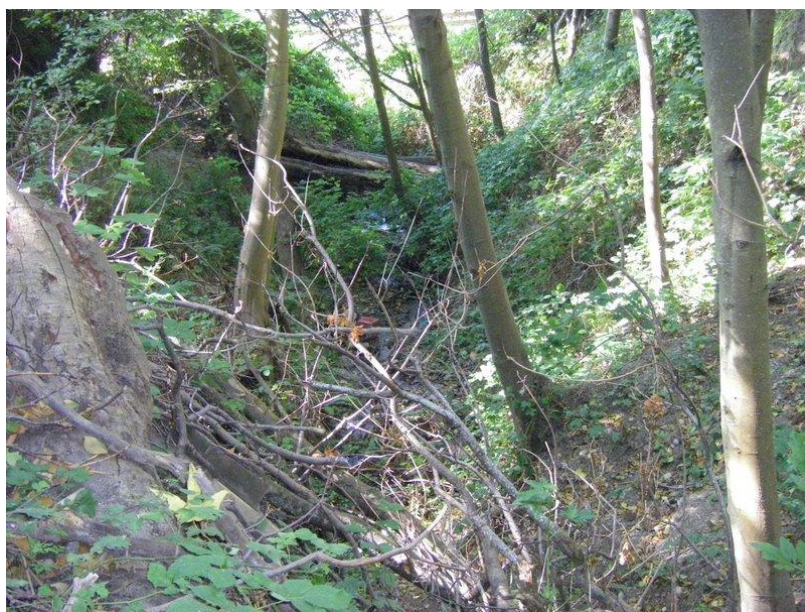
Figure 3. View of lower Heron Creek, showing trees of sufficient maturity to suggest that the broader, deeper canyon here has existed in its present form for at least several decades (and possibly much longer)

most immediately at Heron Creek just south but also at nearby Boeing Creek and Pipers Creek, indicate that Storm Creek is anomalous – every other channel in the region has already created a relatively smooth grade down to Puget Sound, over a sufficient amount of time for mature trees to have become well-established in their valley bottoms (Figure 3). Such a differential cannot be obviously explained by “human” factors, such as the age of development (which is roughly the same throughout this portion of the coast) or direct channel modification, and so other explanations must be explored.

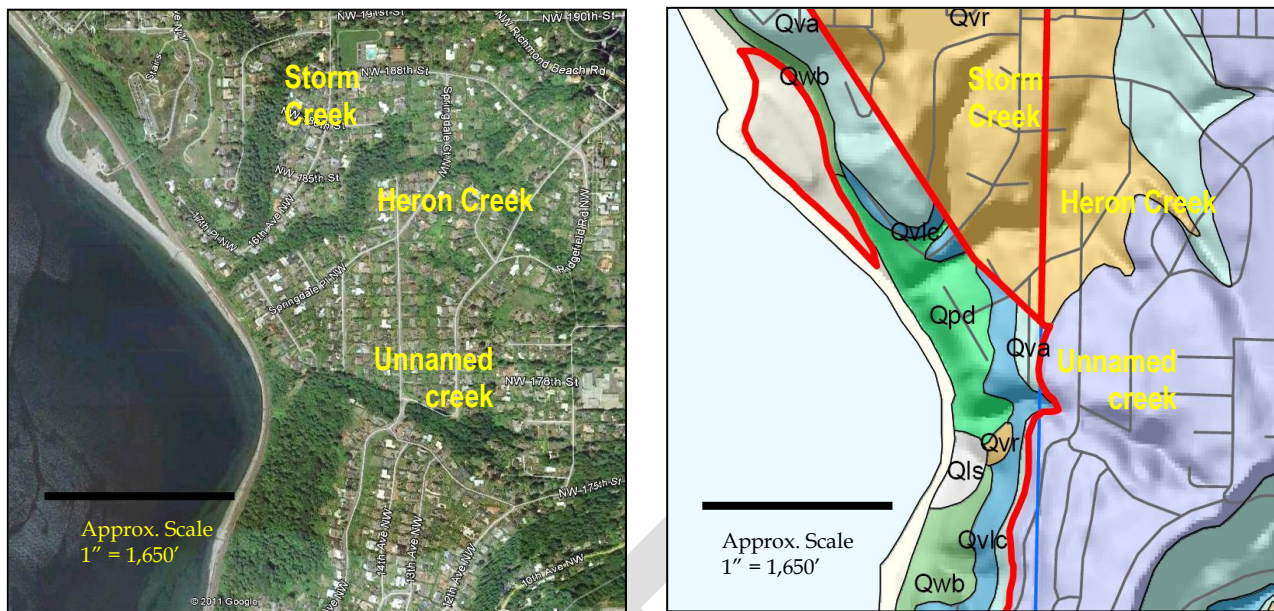
Note: Each image shows an area that is approximately 1 mile wide. The two creeks (and a smaller unnamed channel just south) drain across a localized body of unit Qpd, a deposit composed of glacial sediment correlated to the second-to-last glacial advance across the region (locally named the "Possession" glacial advance).

Figure 4. Aerial photograph and preliminary geologic map of the Shoreline coastal area in the vicinity of Storm and Heron Creeks

The geologic materials that underlie this part of the lowland are, in part, quite uncommon (Figure 4). They include a sedimentary deposit from a regional ice advance about 60,000 years ago, which was named the “Possession Drift” (its deposits are denoted as “Qpd” on geologic maps of the region). In the exposed ravines of both Storm and Heron Creeks, the deposit is primarily till, a very compact, heterogeneous mixture of gravel, sand, and silt reminiscent of concrete (Figure 5, Photo A). However, it has abundant zones of nearly pure sand and a variety of transecting fractures, which provide avenues of weakness for the action of stream or wave erosion (Figure 5, Photo B).

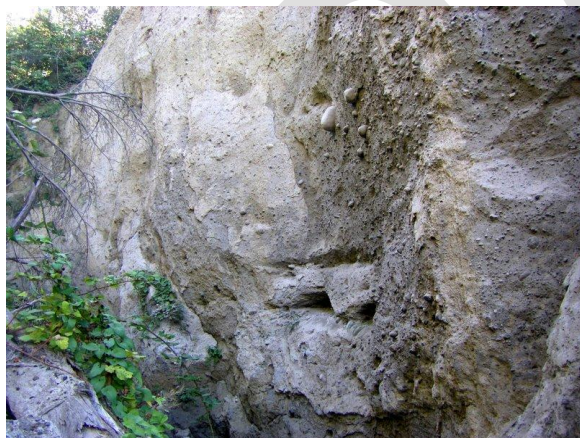
Note: Photo A is the intact coherent material, with sufficient strength to stand in vertical (and locally overhanging) walls for many years without failure. Photo B shows the same geologic deposit in an adjacent area where sandier zones have permitted rapid hollowing out by natural and human agents of erosion.

Figure 5. Glacial till of the Possession age exposed in the lower canyon of Storm Creek

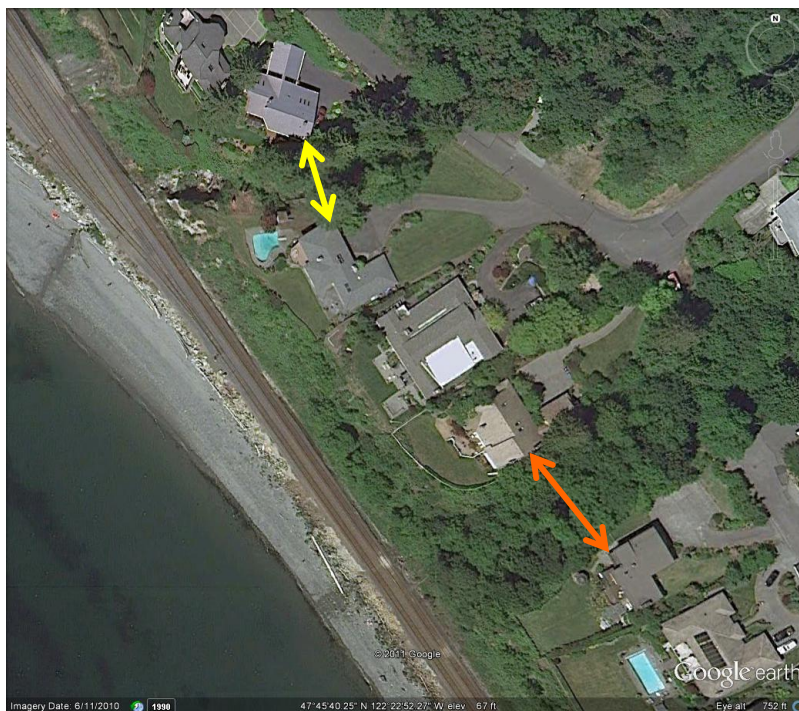
Note: The arrows show the spacing of houses on opposite sides of the two creeks; yellow = 70 ft across Storm Creek; orange = 110 ft across Heron Creek, undoubtedly reflecting the relative depth and width of the two ravines when this area was first developed.

Figure 6. Aerial view of the mouths of Storm Creek (upper left) and Heron Creek (lower right)

We have every reason to assume that a similar runoff response accompanied development in the Storm Creek watershed in the 1960s and 1970s. Stormwater management of that era was well-intentioned but, as is now widely recognized, ineffective at reducing downstream impacts such as flooding and stream erosion. Similar to the rest of the drainages in the region, Storm Creek has been receiving discharges well in excess of its “natural” rates. What is unusual here is that the canyon of Storm Creek is substantially narrower than those of its neighboring creeks, so much so that, for example, in the 1960s, the two houses that flank the mouth of Heron Creek were constructed 110 ft apart, but those that flank Storm Creek are only 70 ft apart (Figure 6; distances approximate as measured in Google® Earth). Although Storm Creek is a larger channel that drains a larger watershed, it had not incised nearly as deeply when the residential structures were built, and so it required (at the time) significantly less setback of structures from a significantly shallower ravine.

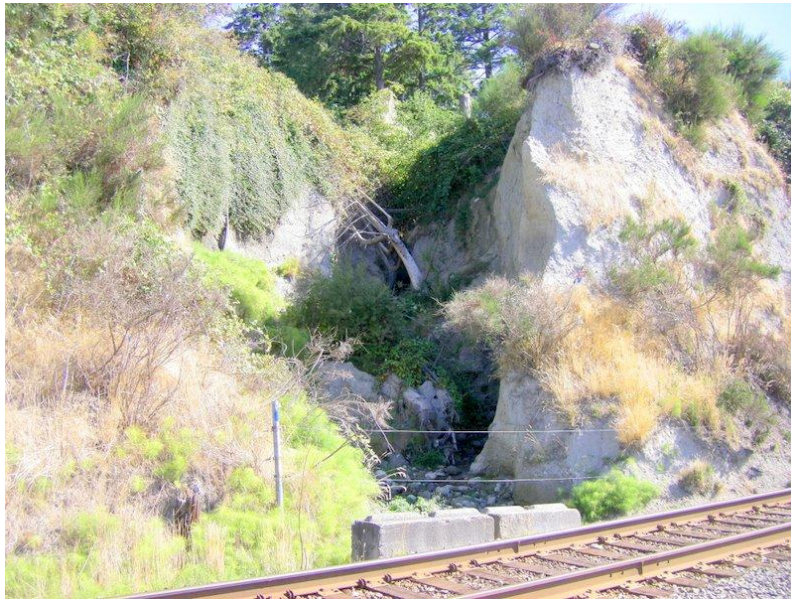
Figure 7. View of the mouth of Storm Creek, from the railroad embankment just above the southern extent of the beach at Richmond Beach Park

pace of headward expansion. Of much greater potential public concern is the health and safety of visitors to Richmond Beach Park who are inclined to explore the adjacent coastline, complete with crumbling bluffs and overhanging caverns (Figure 7). Lastly, the catastrophic collapse of a portion of the ravine sidewalls (or the rapid flushing of previously eroded sediment during a storm) could easily clog the culvert under the railroad tracks and potentially block the tracks should sufficient material become involved.
