**AGENDA TITLE:** Motion to Authorize the City Manager to execute Change Order No.

1 with MJ Hughes Construction in the amount of \$61,055.12 for the

Richmond Beach Saltwater Park Pedestrian Bridge Repair Project

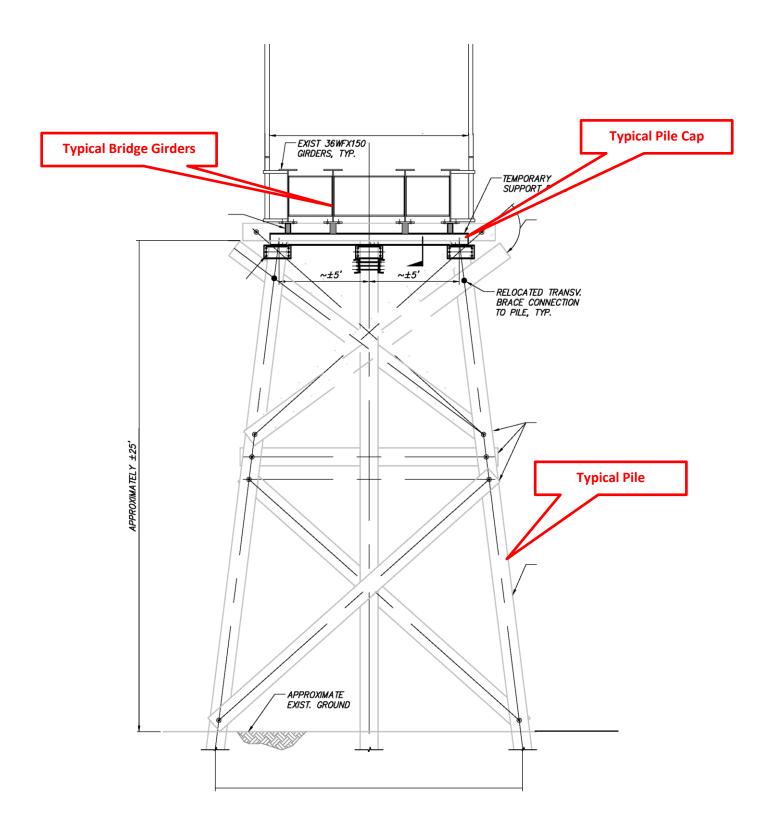
# **Typical Bridge Cross Section**

Additional Pile Repair - A portion of the structural repair work consisted of replacement of two pile caps located nearest to the railroad tracks. The bridge piles are the posts that transfer the bridge load from the bridge deck to the ground. The pile cap is a timber or steel beam that is attached to the tops of the piles and supports the bridge girders. The girders in turn support the bridge deck. Attachment A shows a schematic drawing of these components of the bridge sub-structure.

After close inspection of the piles at the two replacement locations, the structural engineer advised City staff to consider installing additional banding and support around the tops of the piles and pile caps. The main reason for completing this work was to take advantage of the existing railroad permit and current access. The additional support will help ensure the extended life of the bridge and reduce the need to come back for future repairs.

- Fence post replacement (\$26,360).
  60 fence posts were replaced with new powder coated black posts.
- Bridge pile repair (\$3,603).
  Additional banding at six piles and two pile caps.
