# North Maintenance Facility (SNMF) City of Shoreline

# Preliminary SD Supplemental Report

TCF Project No. 2015-016

January 16, 2017

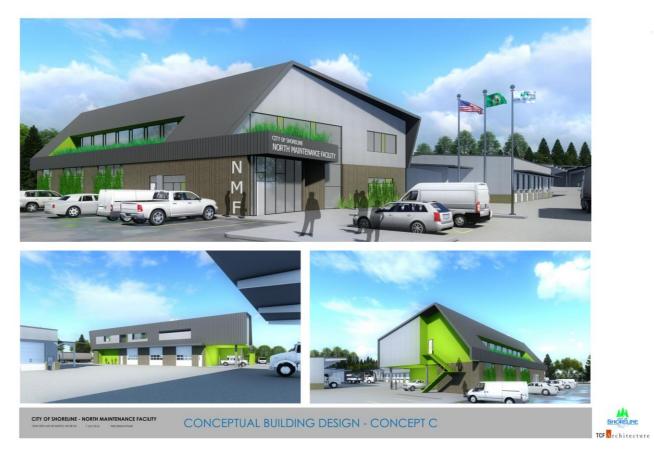
Concept C – Rendering and design used for budgeting purposes

<u>Building Development:</u> Expanding on work initiated in the Predesign Phase, the architecture of each building was further developed. Building massing, heights, and materials and finishes are suggested in the Predesign architectural narrative and conceptual renderings. The final design concept and materiality have not yet been thoroughly reviewed or approved by the City and will be used as the basis for estimating and budget-setting.

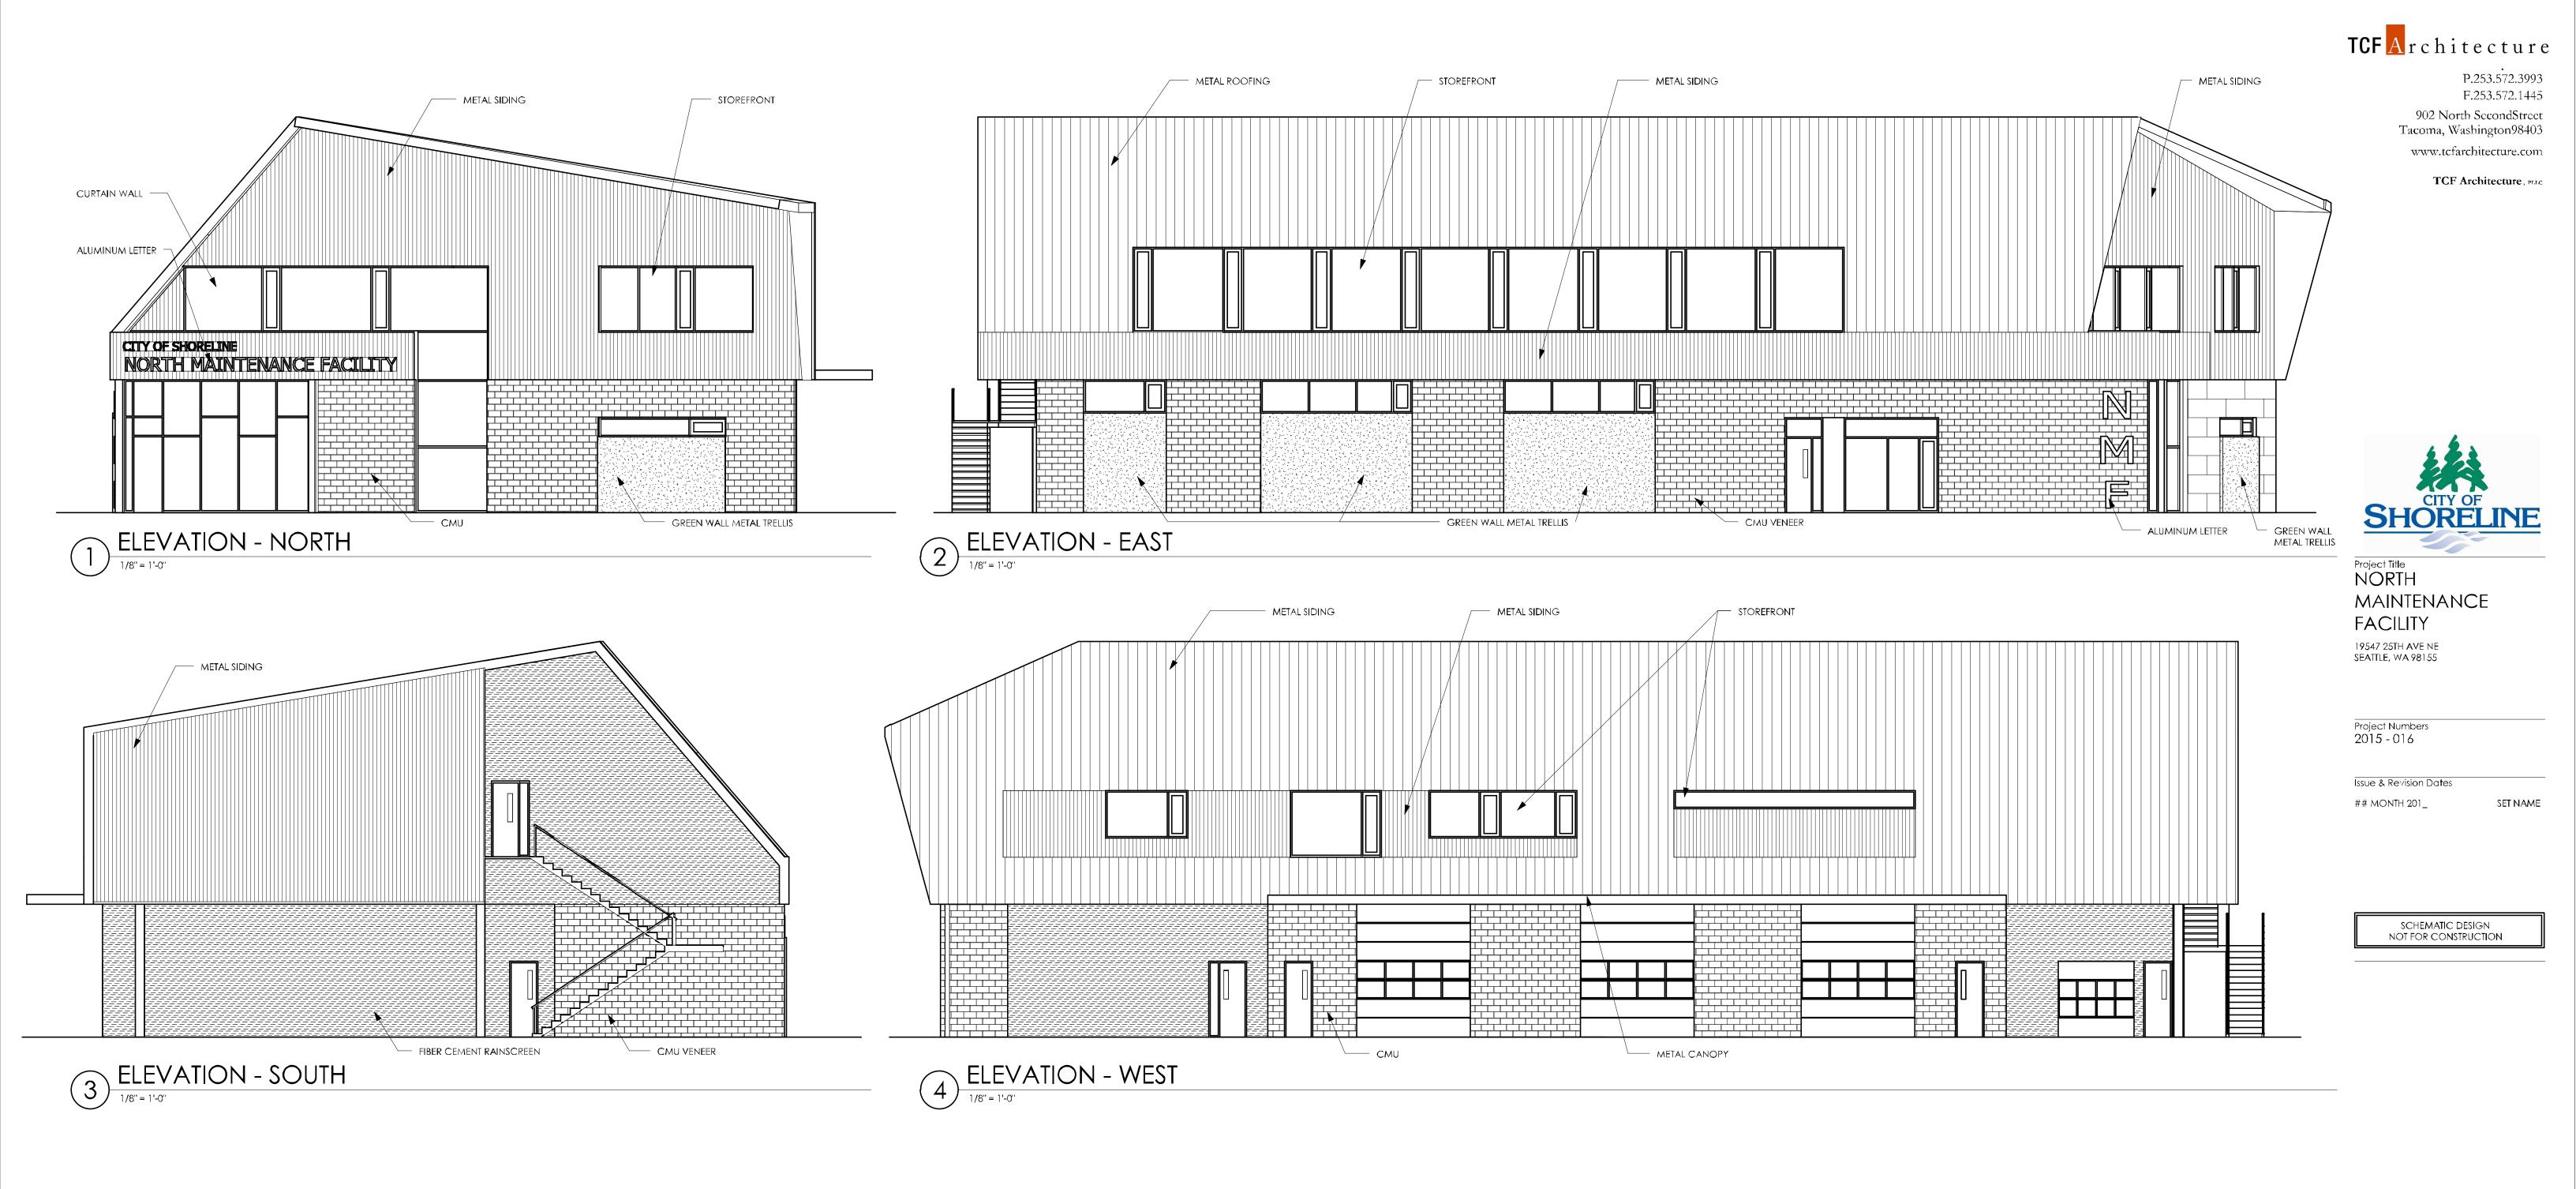
BUILDING A EXTERIOR
ELEVATIONS

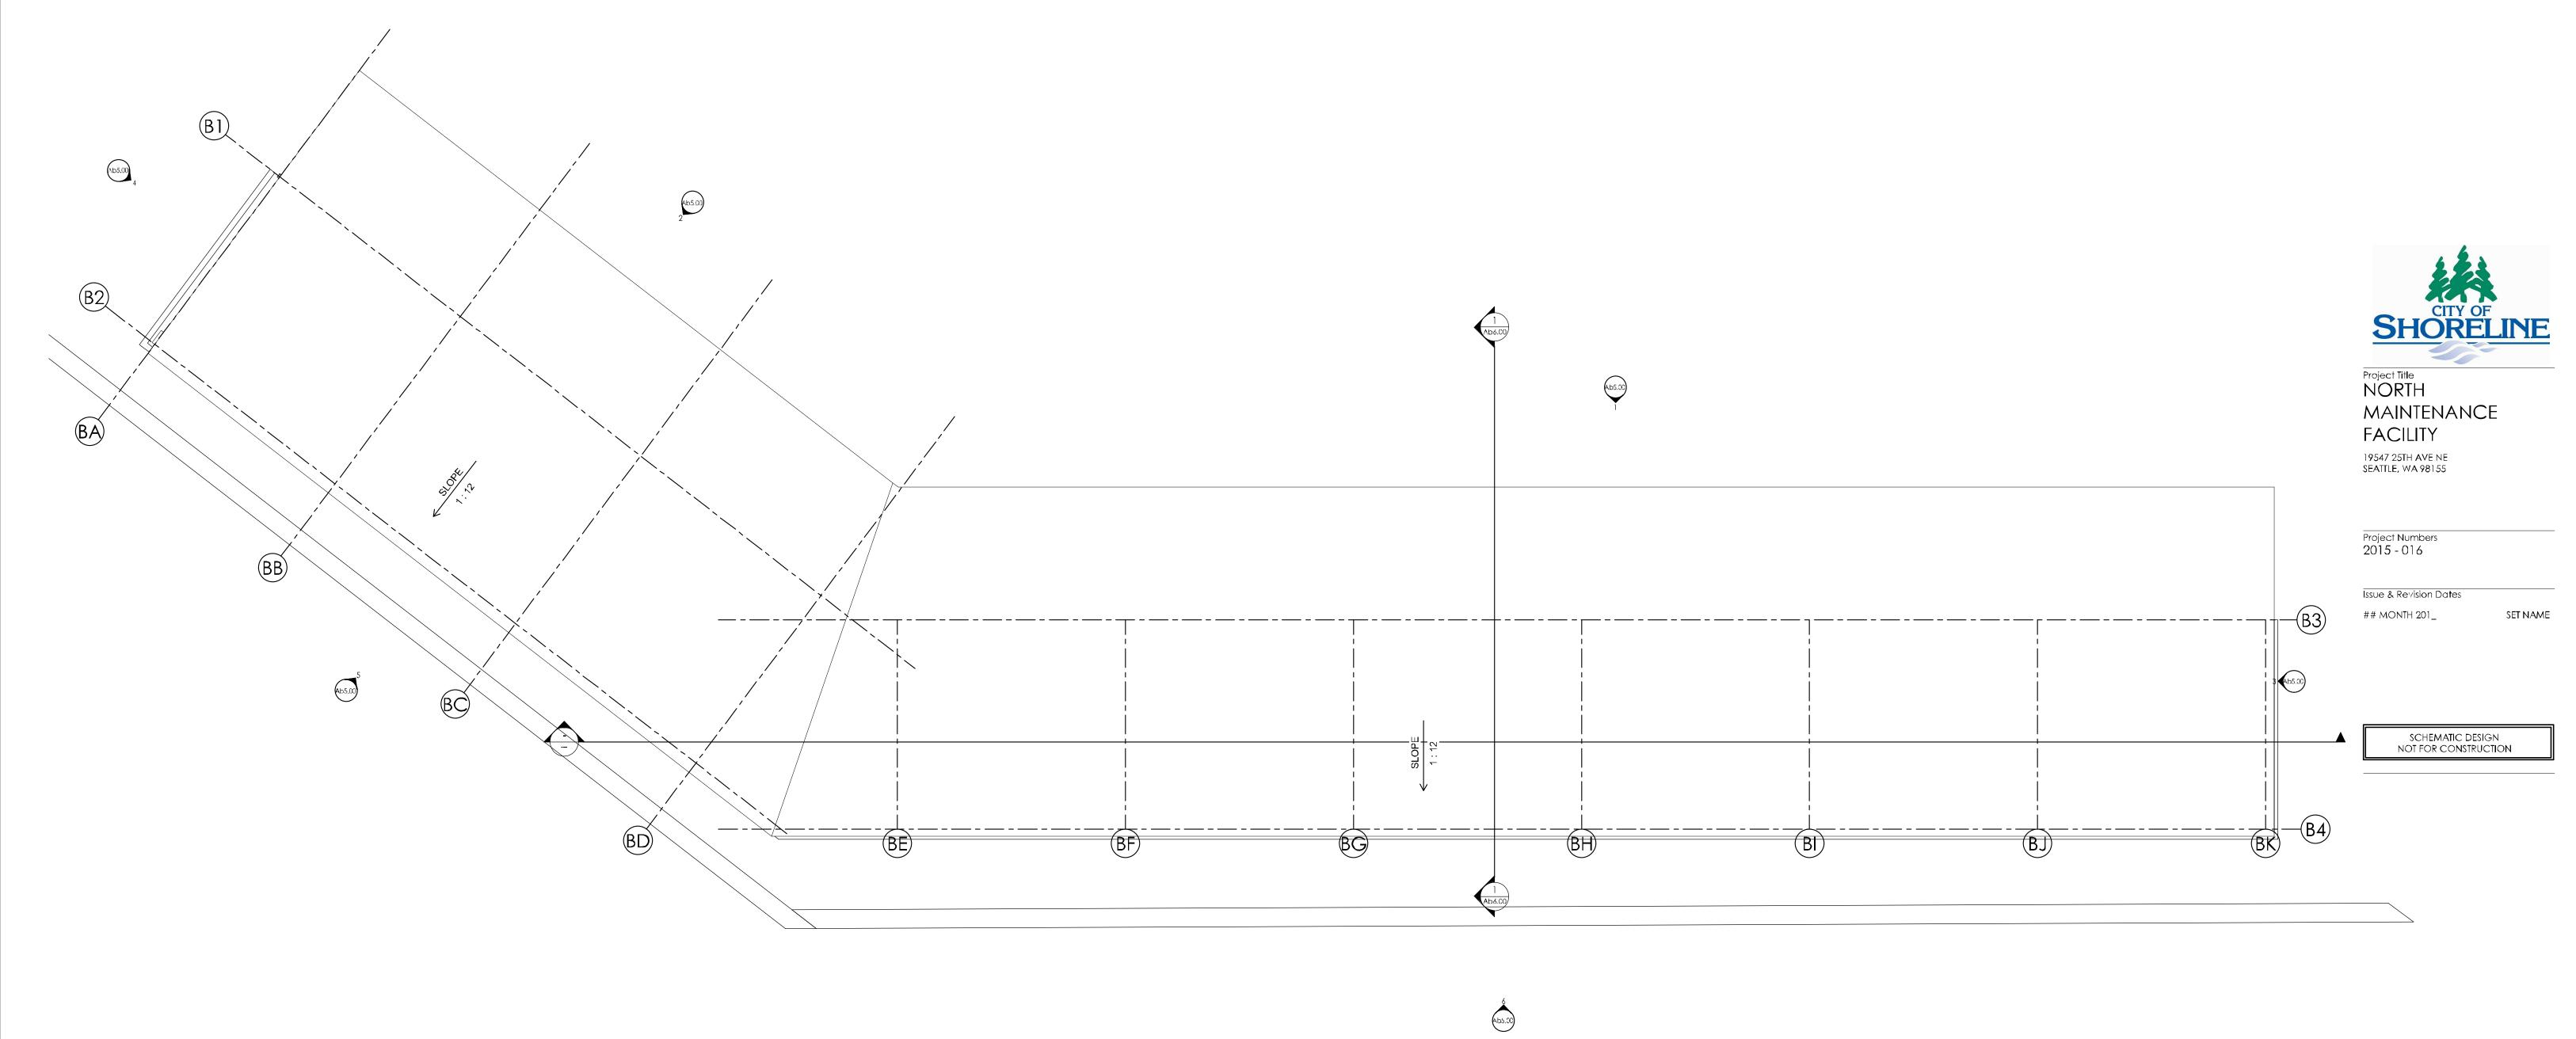
ROOF PLAN - BLDG B

BUILDING B -ROOF PLAN

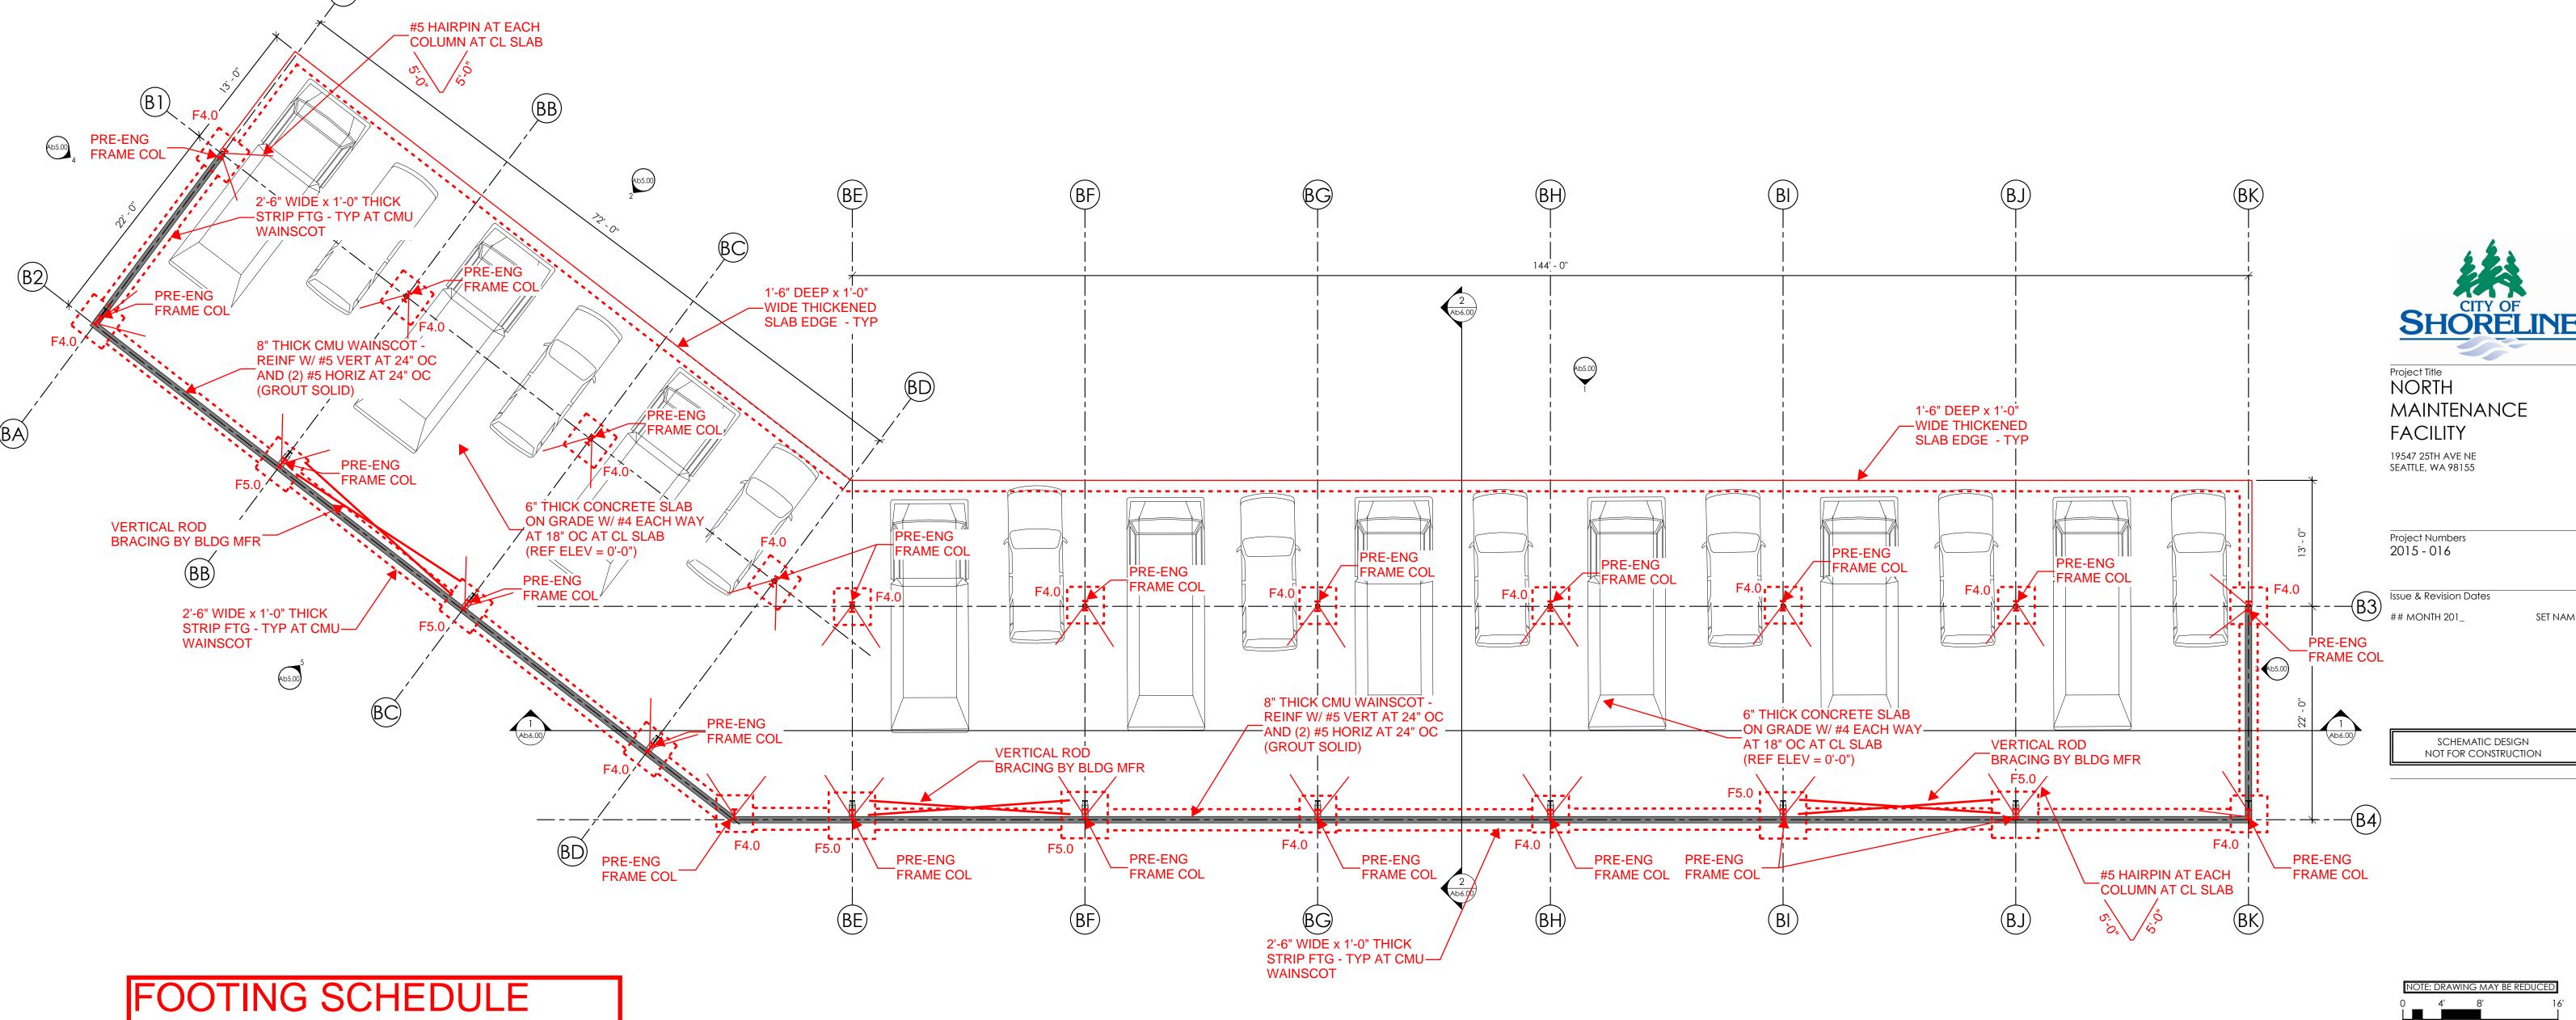
FOUNDATION PLAN - BLDG B

4'-0" x 4'-0" x 1'-0" (5) #5 x 3'-6" EACH WAY 5'-0" x 5'-0" x 1'-4" (6) #5 x 4'-6" EACH WAY

- FOOTING SIZES BASED UPON 2500 PSF ALLOWABLE SOIL PRESSURE

Building B: This building is on the property parcel that is planned to be acquired. Terracon has not completed any explorations on this property to evaluate the expected foundation conditions. The note on the preliminary structural foundation plans states that no overexcavation is required per the soils report. Our preliminary geotechnical report dated 2/25/16 did not address a building on the new property. Explorations on the SNMF site just to the north of the new parcel property line disclosed unsuitable soil (including fill and organic soil) generally consistent with other portions of the SNMF property. The new parcel is topographically higher and may be better ground. However, it is clear to us that the entire area including the SNMF and surrounding areas have been subject to significant grading in the past, which brings considerable uncertainty as to the actual soil conditions on the property to be acquired. Because of the lack of information, we suggest assuming conservatively for purposes of the preliminary cost estimate that the soil conditions on the property to be acquired could be similar to the conditions disclosed on the SNMF property directly to the north. In that case, we suggest assuming at this time (until explorations can be advanced on the property to evaluate the actual soil conditions) that ground improvement could be required within Building B.

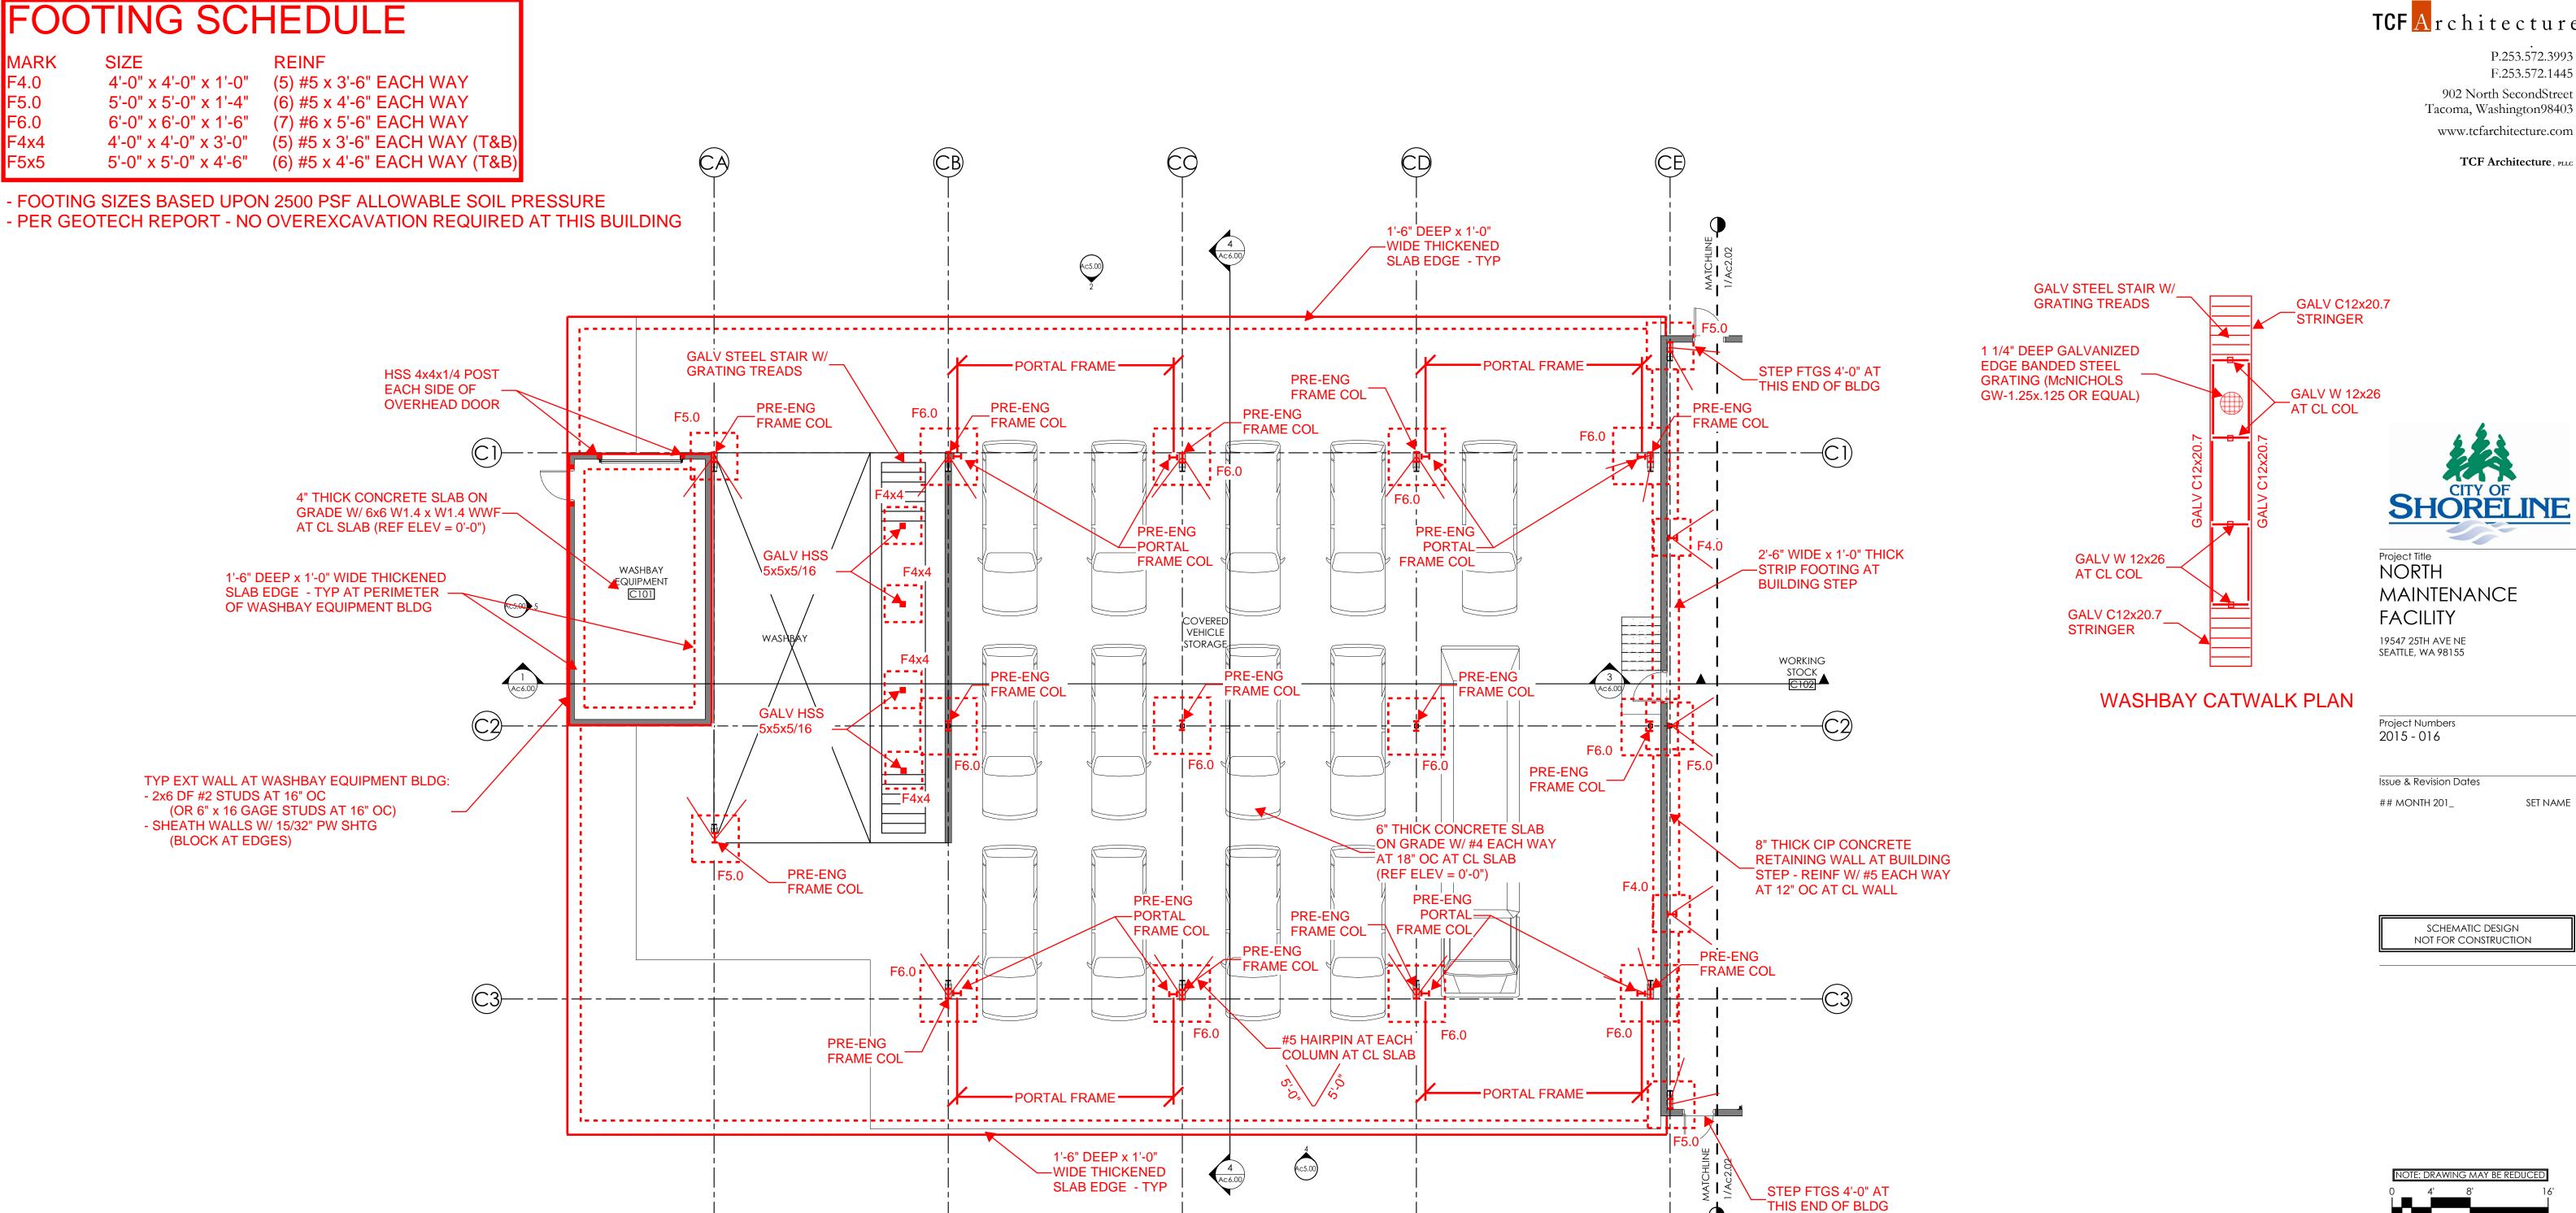
FOUNDATION PLAN - BLDG C

BUILDING C -FOUNDATION PLAN

Building C: The note on the preliminary structural foundation plan states that no excavation is required at this building per the geotechnical report. That statement is not consistent with the findings of our site explorations or our geotechnical report. Soil disclosed in our explorations within and adjacent to Building C disclosed variable quality of fill (including significant quantities of debris in one of the recent test pits near the west side of the building) and buried peat near the east end of the proposed building. We recommend that it be assumed that ground improvement would be required for this entire building.

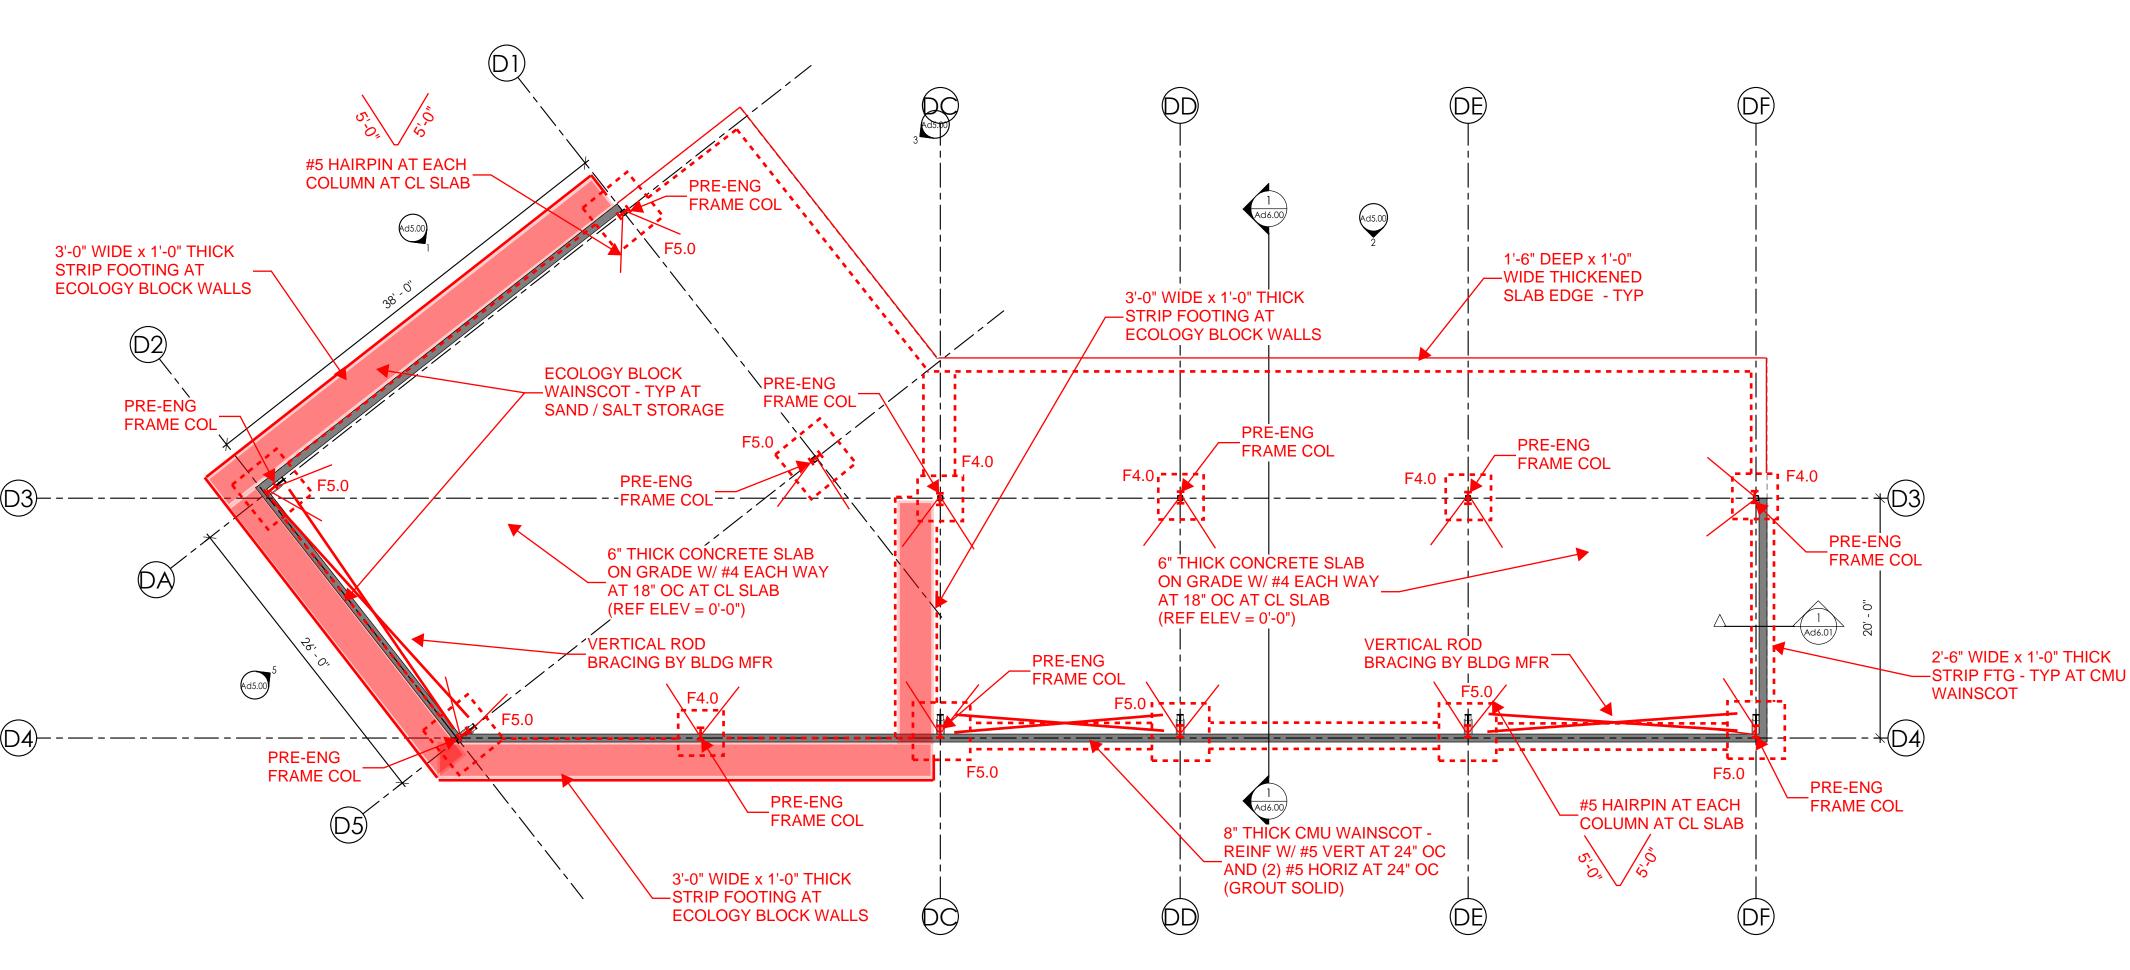
FOUNDATION PLAN - BLDG D

BUILDING D FOUNDATION
PLAN

Building D: The note on the preliminary structural foundation plans identifies the need for overexcavation and replacement or geopiers. We concur based on the available information at that location.
