Site Visit Report completed by Ryan Odegaard.

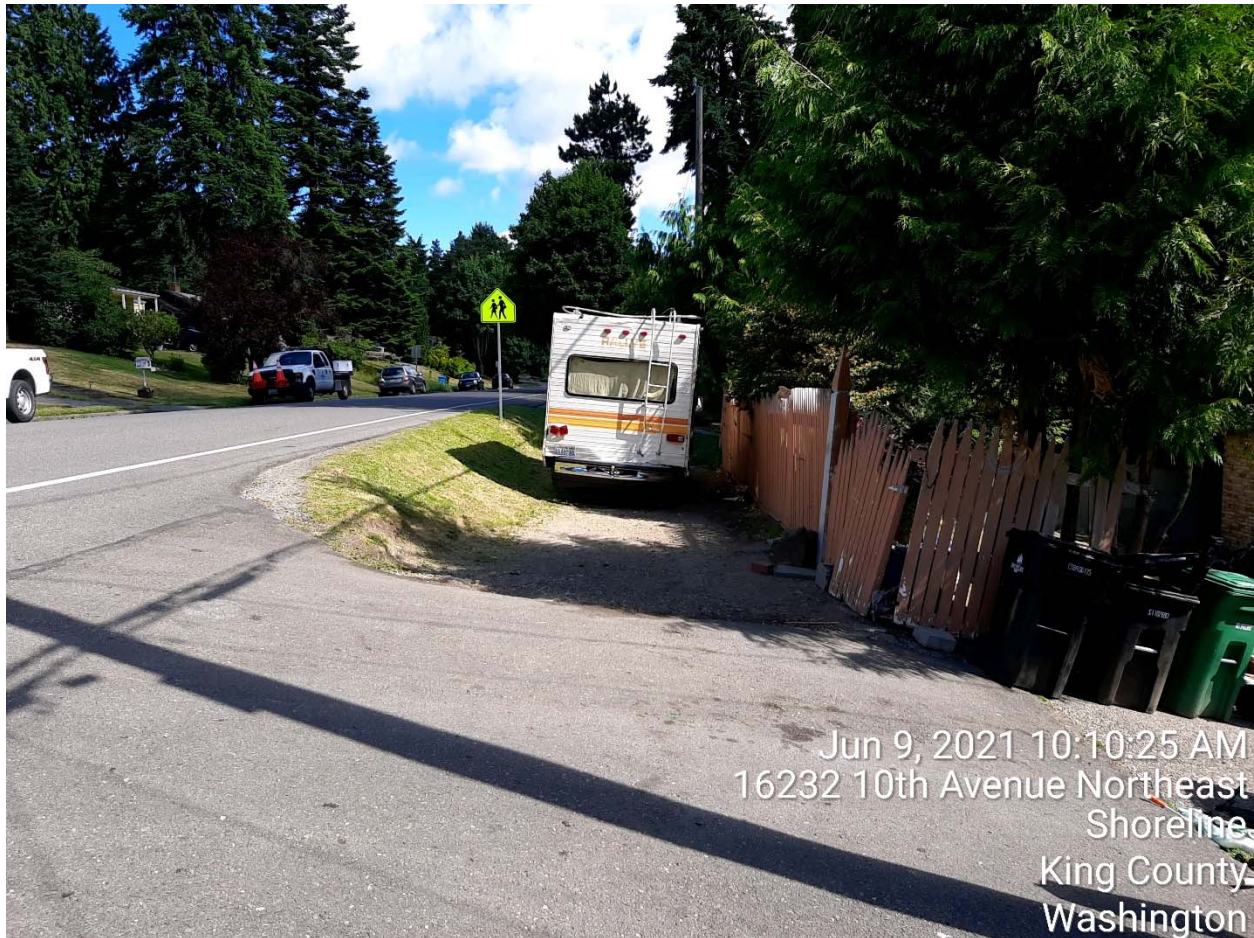
The ROW strip located in front of the home is owned by the city, however maintained by the property owner. The property owner has altered the ROW area as to allow parking. The use of unapproved materials has been placed, removed, and replaced again for parking and is not permitted by the city as this is an unapproved parking surface. Located in the ROW is a white Dodge Rallye. The vehicle in the ROW is operational, however it was defined as being "rented" to a tenant at the time of the visit. The tenant is unwanted at the home, however will not leave the recreational vehicle after being asked to vacate the property by the homeowner. The homeowner stated that the tenant leaves debris in the ROW causing additional garbage. Additional occupants of the recreational vehicle visit the tenant. The names of the occupants are unknown and believed to have been priorly homeless before moving to the residence.

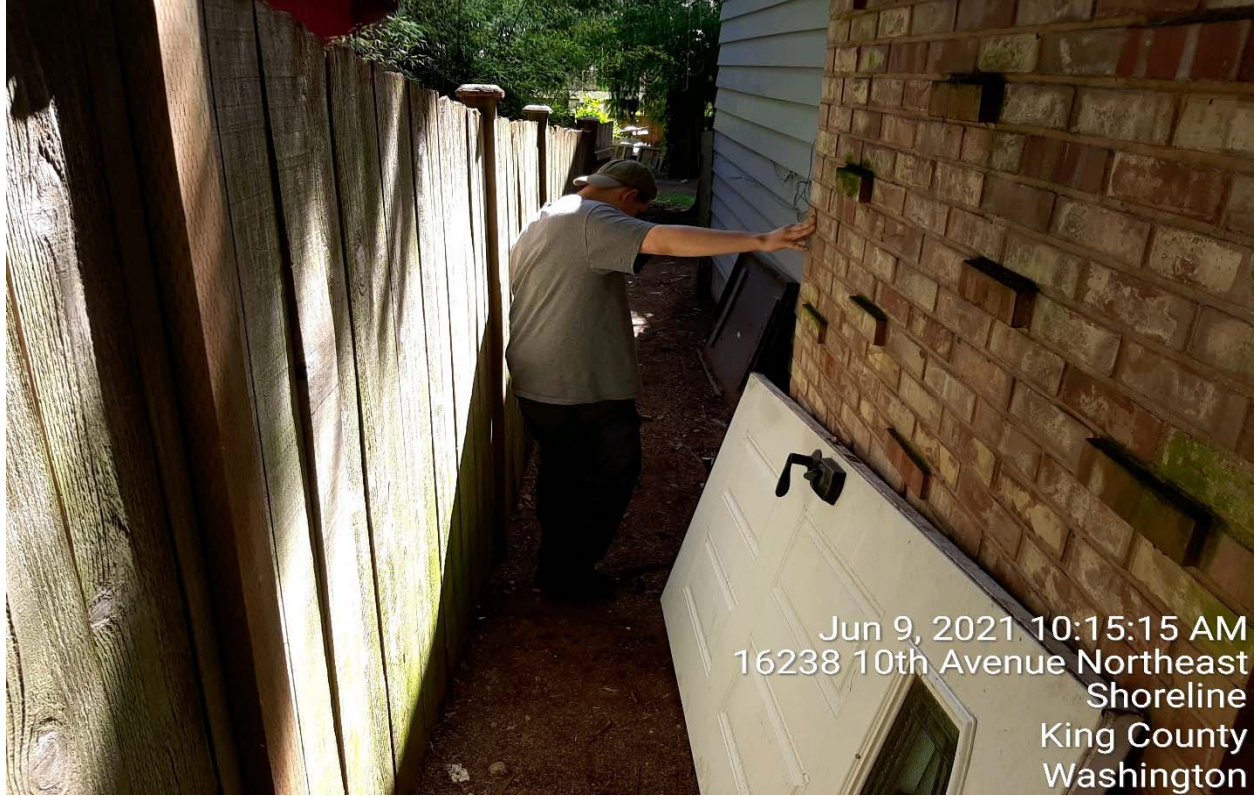
Jun 9, 2021 10:15:15 AM  
16238 10th Avenue Northeast  
Shoreline  
King County  
Washington

The north side of the property is fenced to separate the property from the home to the north. This area had a bike, old entrance door, steel metal grate, landscape blocks, table, tarp and window placed in the walkway. The bike was functional, however the door, metal grate and window were damaged and defined as refuse.

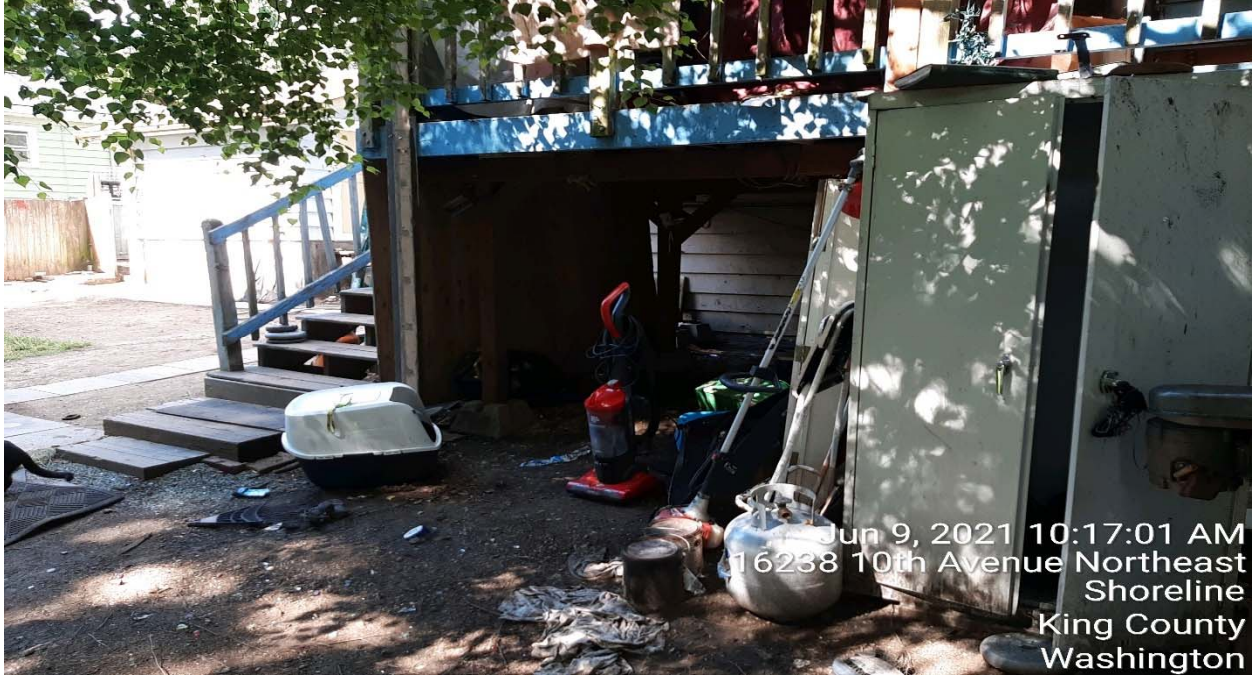
The below photo is of the outdoor shelter established on the deck.

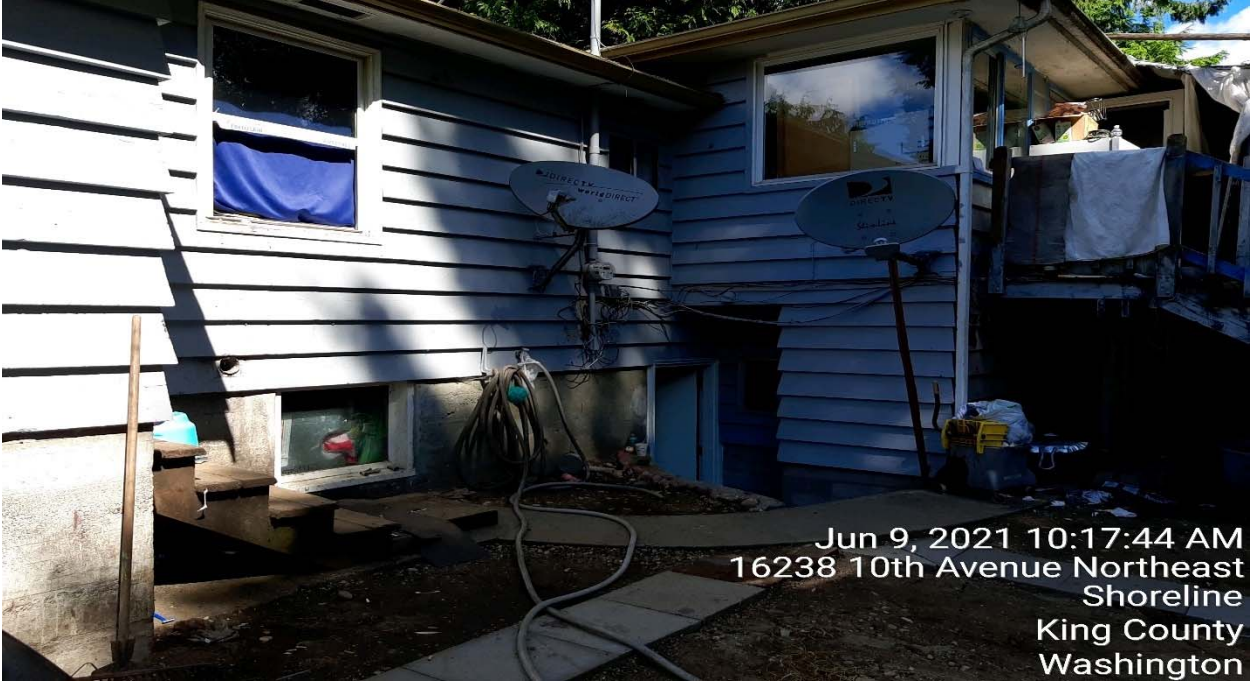
This photo shows the entrance and exit areas from the home basement and outdoor deck from the main living area of the home.

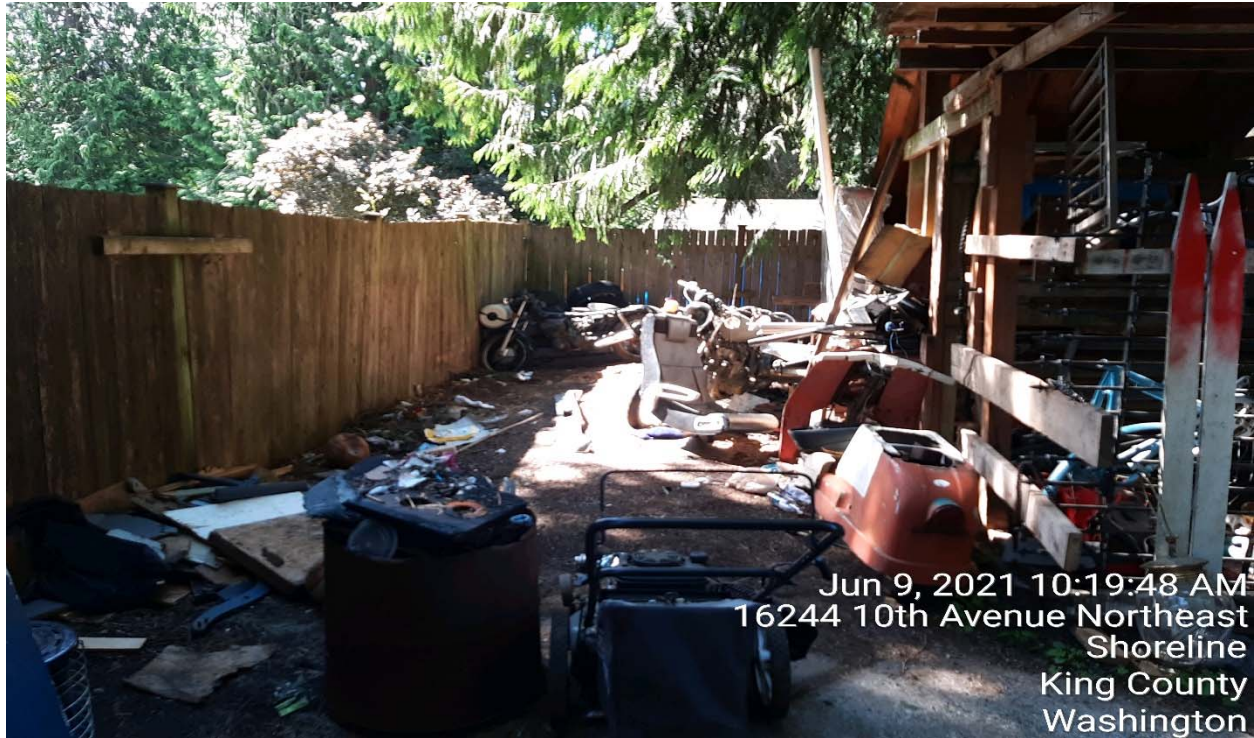
Photo below of exterior camping and living entrance. Location is South / East corner of property.

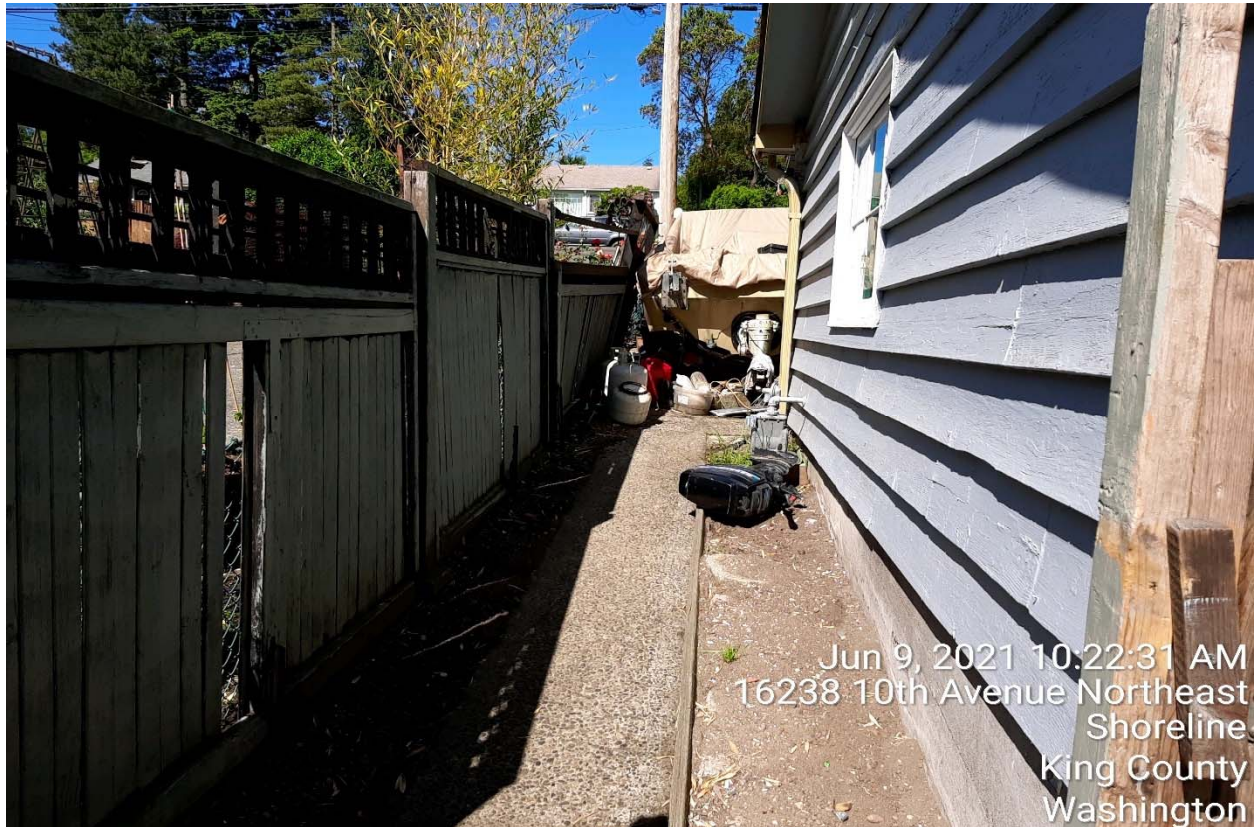
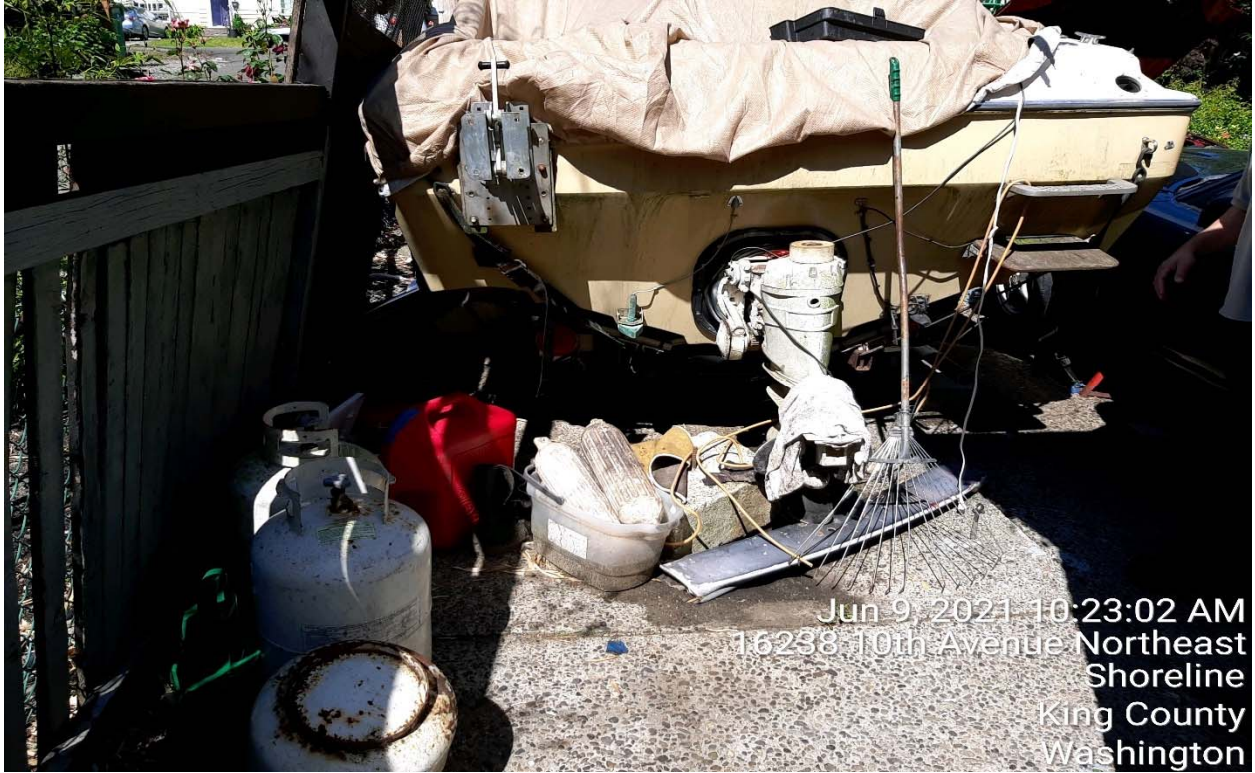
Jun 9, 2021 10:23:02 AM  
16238 10th Avenue Northeast  
Shoreline  
King County  
Washington

South side of the home that leads to driveway. Note that boat motor, gas tanks, propane tanks, and tarps.
